Product: Vinyl floor tiles and covering

Product Name	Vinyl floor tiles and covering
Product type	Floor Covering
Sub-Product type	Floor Tiles
Trading name(s)	
Other name(s)	Floor tiles, vinyl floor, plastic tiles, lino or linoleum.
Product description	<p>Solid, brittle material in a variety of colours used in control rooms, bathrooms, common rooms and amenities rooms of zone substations and Field Service Centres. Sometimes used in bigger distribution substations.</p> <p>Can also be referred to as lino or linoleum.</p>
Build element	Construction
Product identification	
Asbestos-containing vinyl floor tiles can have a variety of colours and shapes, but they will look exactly the same as non-asbestos-containing vinyl floor tiles. Reliable identification can only be achieved by laboratory analysis.	
Known uses	Durable flooring
Asbestos fibre type	Chrysotile (white asbestos)
Friable or Non-Friable	Non-Friable
Known Supplier(s)	
Known place of manufacture

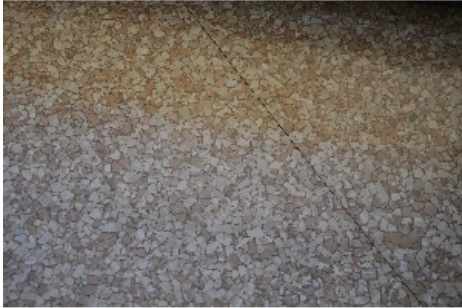
Asbestos Homes 101.JPG

Name	Vinyl Floor Covering - Commercial
Caption	Commercial Vinyl Floor Covering which contains asbestos in the backing
Location	Commercial
Source	Asbestos Education Committee
Image Id	93

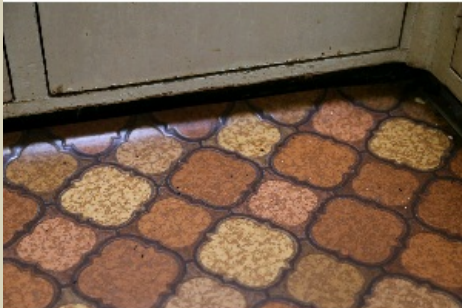
IMG_0103.jpg

Name	Vinyl Floor Covering - Kitchen 1
Caption	Domestic vinyl floor covering in a kitchen - it is lifting at the base of the cupboard
Location	Domestic home
Source	Asbestos Education Committee
Image Id	94

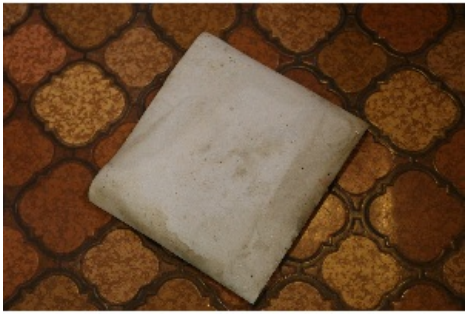
IMG_0124.jpg

Name	Vinyl Floor Covering - Kitchen 1b
Caption	Domestic vinyl floor covering in a kitchen and laundry which pictures the underside of a loose section
Location	Domestic home
Source	Asbestos Education Committee
Image Id	95

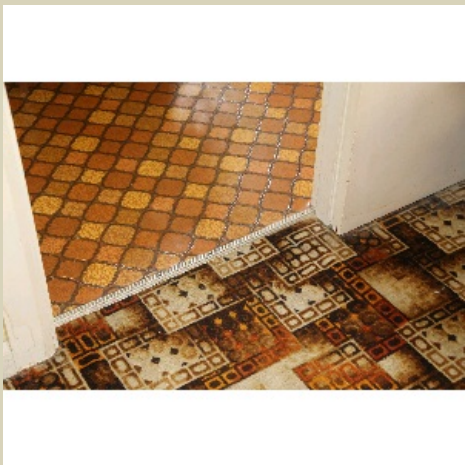
IMG_0156.jpg

Name	Vinyl Floor meets Capet
Caption	Domestic vinyl floor covering which meets carpet.
Location	Domestic home
Source	Asbestos Education Committee
Image Id	96

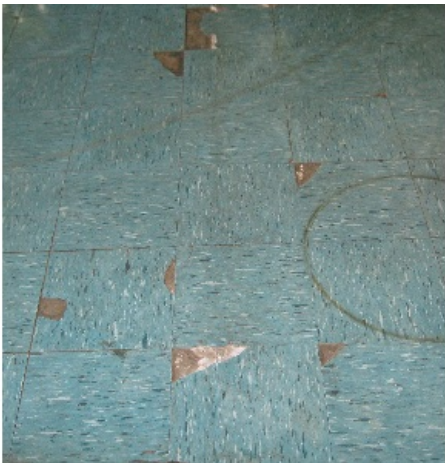
Vinyl Floor Tiles - photo courtesy of Townsville Asbestos.jpg

Name	Lino Floor Tiles
Caption	Comercial lino floor tiles
Location	Commercial

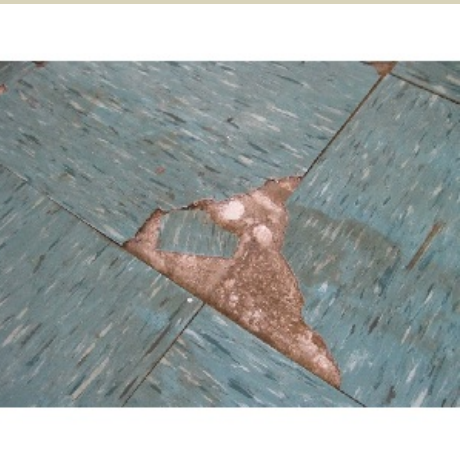
Vinyl floor tiles damaged - photo courtesy of Townsville Asbestos.jpg

Name	Lino Floor Tiles
Caption	Commercial lino floor tiles - damaged
Location	Commercial
Source	Townsville Asbestos
Image Id	98

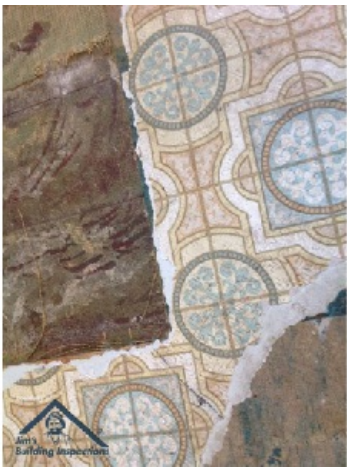
JBIFloor Covering - Confirmed_.jpg

Name	Vinyl Floor Covering - Kitchen 2
Caption	Domestic vinyl floor covering in a kitchen which has been partially removed exposing asbestos cement floor and adhesive.
Location	Domestic home
Source	Jim's Building Inspections
Image Id	230

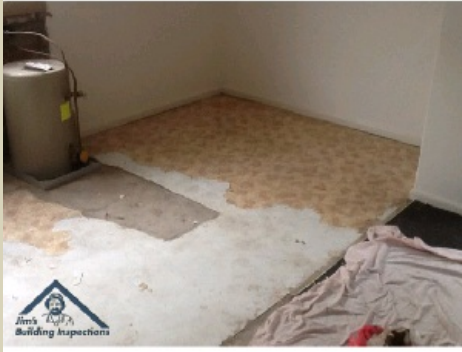
JB_I_Vinyl Floor Covering - Confirmed (2).jpg

Name	Domestic Vinyl Floor Covering
Caption	Domestic vinyl floor covering
Location	Domestic home
Source	Jim's Building Inspections
Image Id	231

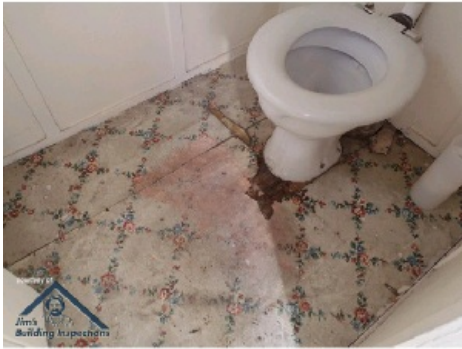
JB_I_Vinyl Floor Covering - Confirmed.jpg

Name	Domestic Vinyl Floor Covering - toilet
Caption	Domestic vinyl floor covering in a toilet and bathroom
Location	Domestic home
Source	Jim's Building Inspections
Image Id	232

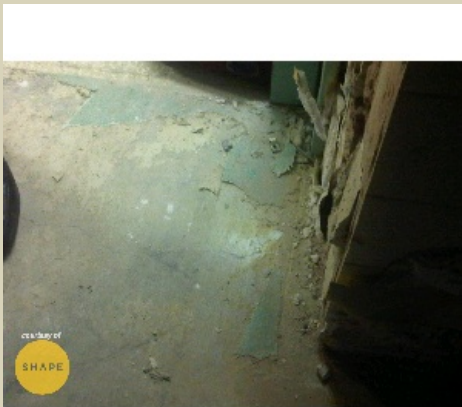
865.jpg

Name	Remnants of Asbestos backed vinyl flooring
Caption	Asbestos backed vinyl sheet flooring. The green material indicates the backing which contains asbestos.
Location	Industrial

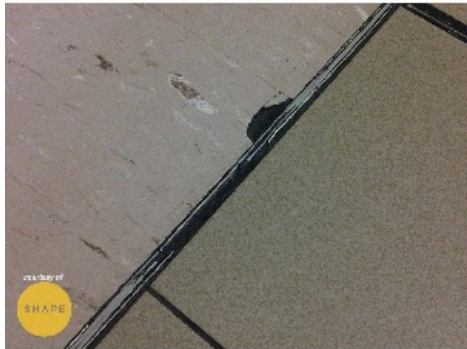
1119.jpg

Name	Vinyl Floor Covering - Commercial
Caption	Vinyl floor tile with backing that contains asbestos.
Location	Commercial
Source	SHAPE Group
Image Id	268

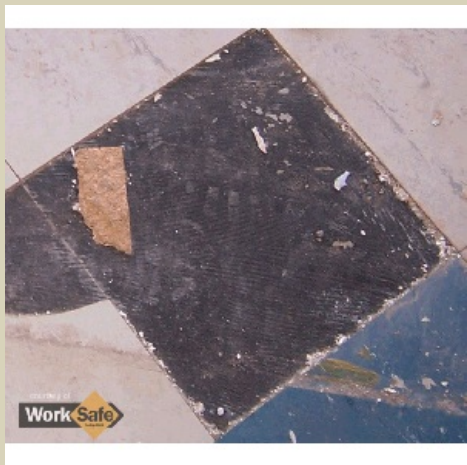
WST_blackjack-glue.jpg

Name	Close up Vinyl Floor Covering - Commercial
Caption	Asphaltic cutback adhesive under vinyl tiles
Location	Commercial
Source	WorkSafe Tasmania
Image Id	269

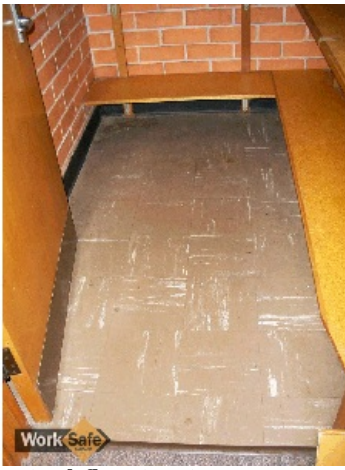
WST_vinyl-flooring.jpg

Name	Vinyl Floor Covering in public building
Caption	Vinyl Floor Covering in public building
Location	Other
Source	WorkSafe Tasmania
Image Id	270

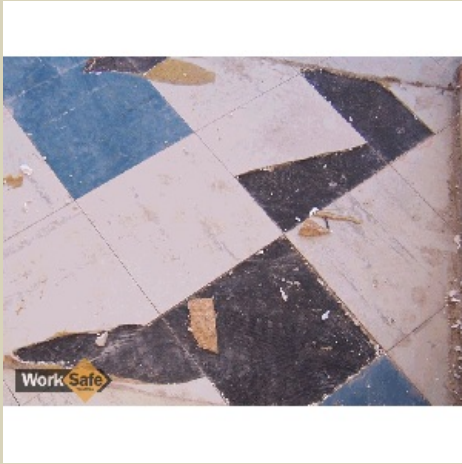
WST_vinyl-floor-tiles.jpg

Name	Vinyl Floor Covering
Caption	Asphaltic cutback adhesive under vinyl tiles
Location	Commercial
Source	WorkSafe Tasmania
Image Id	271

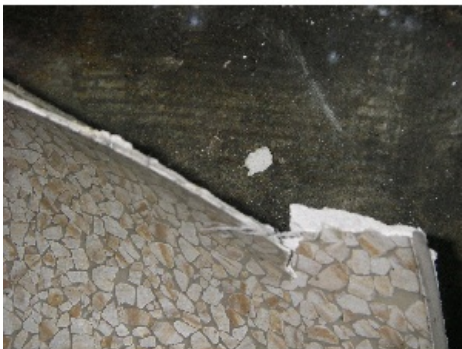
IMGP1527.JPG

Name	Close up Vinyl Floor Covering - Commercial
Caption	Close up Vinyl Floor Covering - Commercial
Location	Commercial

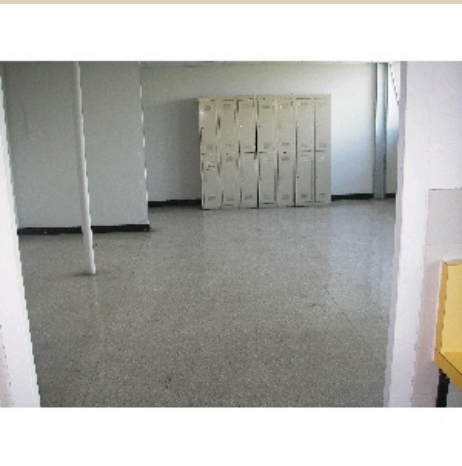
IMGP1533.JPG

Name	Vinyl Floor Covering - Commercial
Caption	Vinyl Floor Covering - Commercial
Location	Commercial
Source	Prensa
Image Id	358

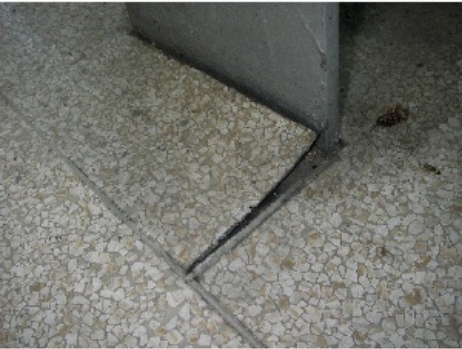
IMGP1536.JPG

Name	Close up Vinyl Floor Covering - Commercial
Caption	Close up Vinyl Floor Covering - Commercial
Location	Commercial
Source	Prensa
Image Id	359

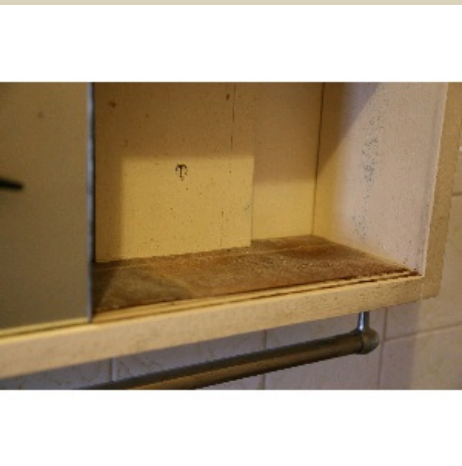
IMG_0502.JPG

Name	Vinyl flooring as liner
Caption	Vinyl flooring used as shelf liner in bathroom
Location	Domestic home
Source	Asbestos Awareness
Image Id	368

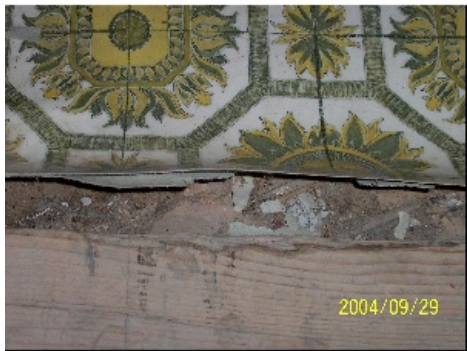
asbestos paper under lino.jpg

Name	Asbestos paper under lino
Caption	Asbestos paper under lino
Location	Domestic home
Source	Prensa
Image Id	369

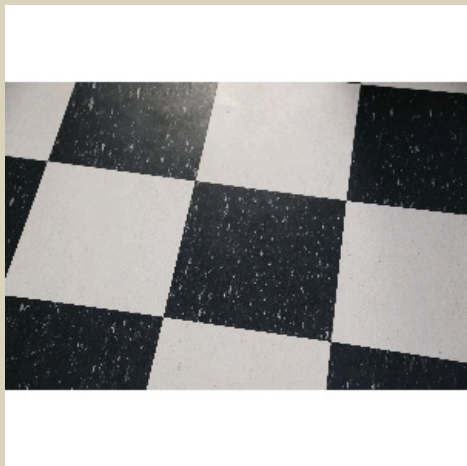
Lino Floor 1783 Courtesy Asbestos Awareness.JPG

Name	Lino Tiles - BW
Caption	Domestic lino floor tiles
Location	Domestic home
Source	Asbestos Awareness
Image Id	370

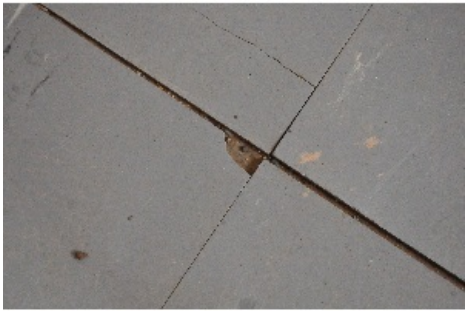
DSC_0155.JPG

Name	Lino Tiles - lifting
Caption	Commercial lino floor tiles - lifting
Location	Commercial
Source	Asbestos Awareness
Image Id	371

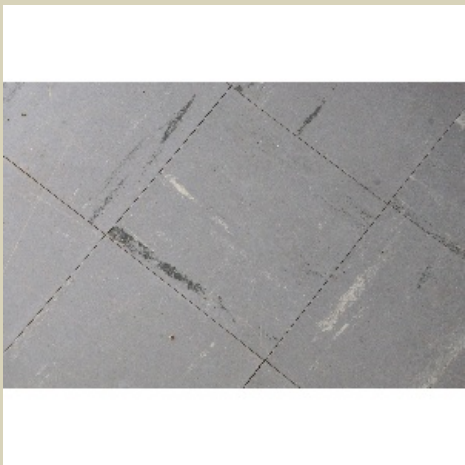
DSC_0161.JPG

Name	Commercial Lino Tiles
Caption	Commercial lino floor tiles - lifting
Location	Commercial
Source	Asbestos Awareness
Image Id	372

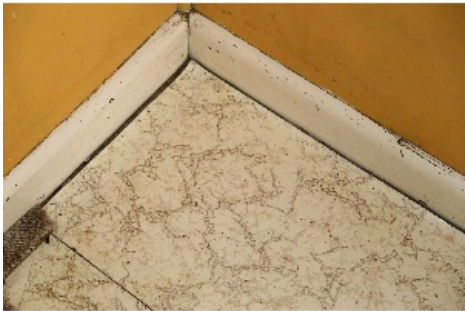
IMG_0090.JPG

Name	Domestic Vinyl Floor Covering
Caption	Domestic vinyl floor covering
Location	Domestic home
