Product: Door, Window, Cornice & Joining Strip Mouldings

Product Name	Door, Window, Cornice & Joining Strip Mouldings
Product type	Asbestos Cement Fixings
Sub-Product type	
Trading name(s)	
Other name(s)	architrave
Product description	Used as architrave around doors and windows, window sills also used a AC sheet joining strips can have plain or spigoted ends, including louvre blades, also used as cornices. A round nail can be visible on the strip, usually just above surface. Commonly used as joining strips, window and door architrave.
Build element	Construction
Product identification	
Round nail visible on the strip, usually just above surface. Commonly used as joining strips, window and door architrave.	
Known uses	Commonly used as joining strips, cornices, window and door architrave.
Asbestos fibre type	Chrysotile (white asbestos)
Friable or Non-Friable	Non-Friable
Known Supplier(s)	James Hardie
Known place of manufacture	
Date / period of manufacture	
Building construction period	1900-1920,1921-1930,1931-1940,1941-1950,1951-1960,1961-1970,1970-1980,1981-1990,Pre 1900

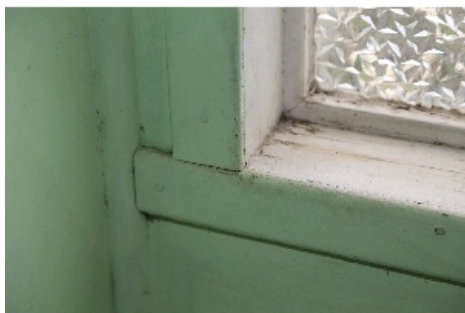
IMG_0130.jpg

Name	Asbestos window trim
Caption	Window architrave made from moulded asbestos cement
Location	Domestic home
Source	Asbestos Education Committee
Image Id	46

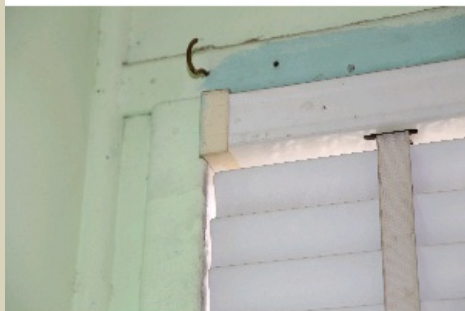
IMG_0131.jpg

Name	Asbestos window trim 2
Caption	Window architrave made from moulded asbestos cement
Location	Domestic home
Source	Asbestos Education Committee
Image Id	47

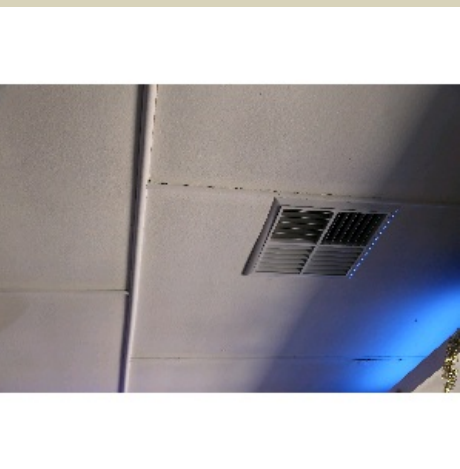
AC Ceiling.JPG

Name	Ceiling joining strip
Caption	Joining strips on AC sheeting ceiling
Location	Commercial
Source	Prensa
Image Id	335

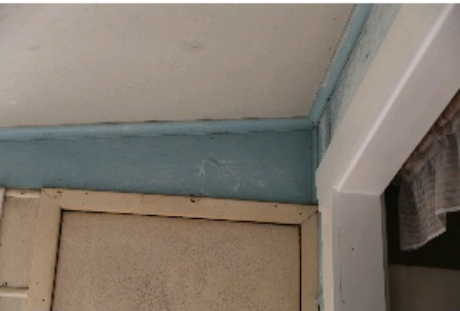
AAD WCS 031.JPG

Name	AC Cornice & Door Architrave
Caption	AC Cornice & Door Architrave, AC Wall and Ceiling
Location	Domestic home
Source	Asbestos Awareness
Image Id	336

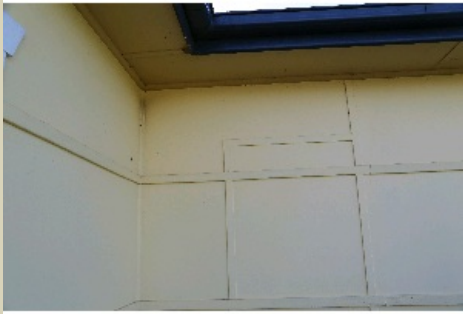
AAD WCS 013.JPG

Name	Exterior Joining Strips
Caption	Exterior Joining Strips
Location	Domestic home
Source	Asbestos Awareness
Image Id	337

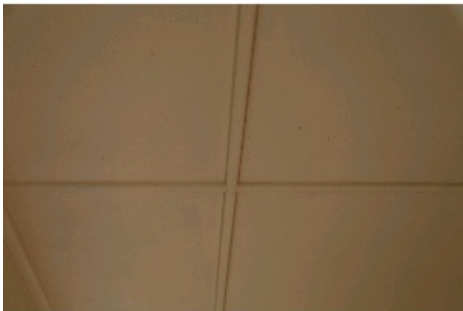
Internal Ceiling 2550 Courtesy Asbestos Awareness.JPG

Name	Ceiling joining strip
Caption	Ceiling joining strips
Location	Domestic home
Source	Asbestos Awareness
Image Id	338

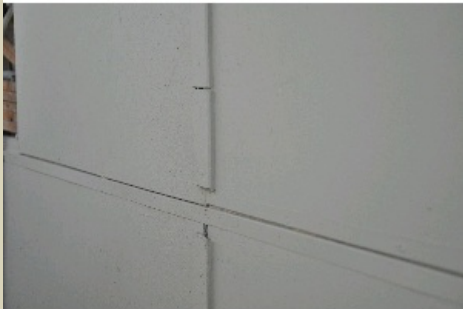
0075AsbestosProduct.JPG

Name	Exterior Joining Strips
Caption	Broken exterior / external moulded asbestos joining strips on AC wall
Location	Domestic home

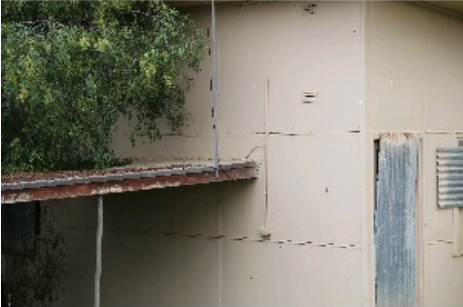
External Walls 2336 Courtesy Asbestos Awareness.JPG

Name	Exterior Joining Strips on AC cement wall
Caption	Exterior Joining Strips on AC cement wall
Location	Domestic home
Source	Asbestos Awareness
Image Id	340

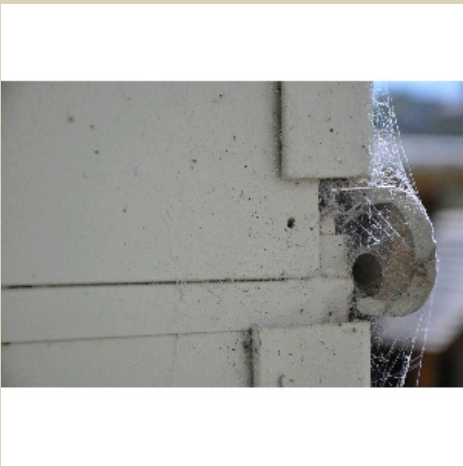
Exterior moulded asbestos joining strip 073.JPG

Name	Exterior Joining Strip & Capping on AC cement wall
Caption	Close up of exterior joining strip end and corner capping on AC cement wall
Location	Domestic home
Source	Asbestos Awareness
Image Id	363

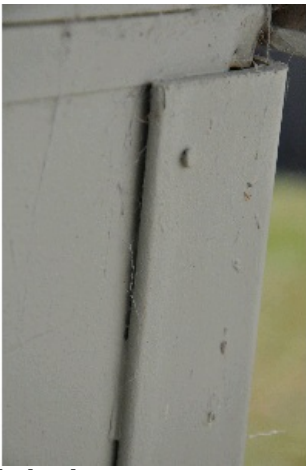
Moulded asbestos corner capping731.JPG

Name Exterior Corner Capping

Caption Moulded exterior AC corner capping. Identifiable through the slightly raised nails.

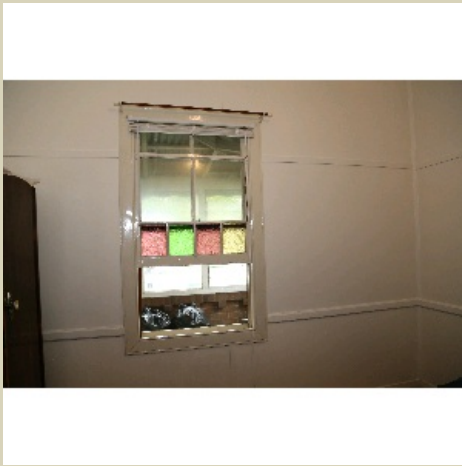
Asbestos Cement Walls_0296.JPG

Name AC wall with joining strips

Caption Asbestos cement wall with moulded asbestos joining strips.

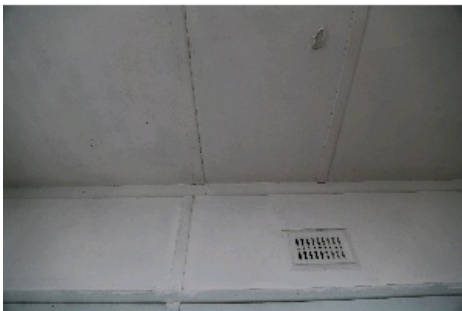
IMG_0138.jpg

Caption Asbestos cement ceiling and wall with moulded asbestos joining strips and cornice.

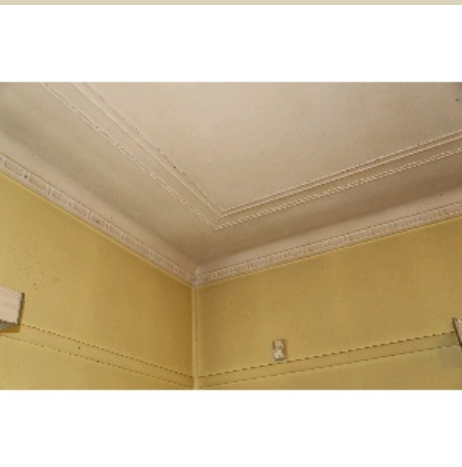
IMG_0163.jpg	
Name	AC wall with moulded asbestos joining strips
Caption	Asbestos cement wall with moulded asbestos joining strips.
Location	Domestic home
Source	Asbestos Awareness
Image Id	378

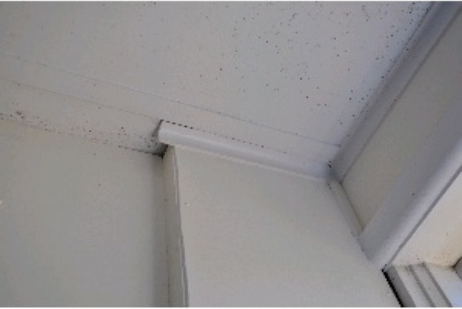
0068AsbestosProduct.JPG	
Name	Moulded Asbestos Cornice
Caption	Moulded Asbestos Cornice on AC wall and ceiling
Location	Domestic home
Source	Asbestos Awareness
Image Id	397
