Product: Plaster

| Product description | A stucco or render building material used for coating walls and ceilings. It is manufactured as a dry powder and is mixed with water to form a paste when used. |

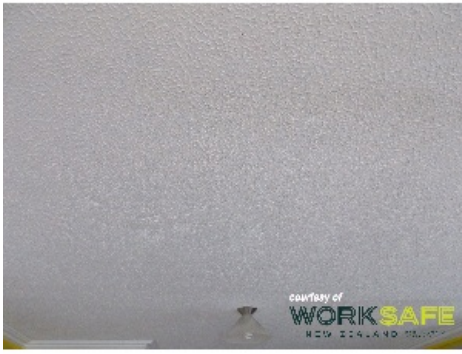
Plaster Ceiling DSCN7848.jpg

Name Plaster ACM Ceiling

Caption Domestic livingroom ceiling with plaster which contains asbestos.

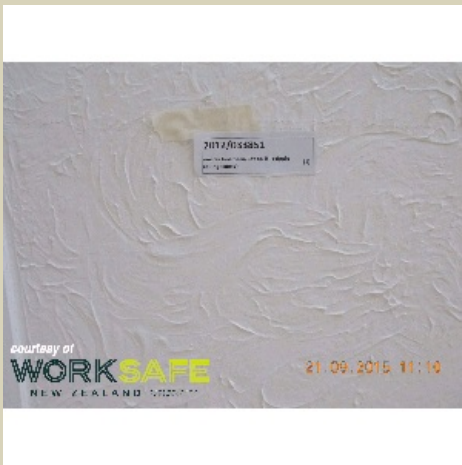
Plaster DSCN7854.jpg

Name Plaster ACM Ceiling

Caption Domestic bedroom ceiling with plaster which contains asbestos.

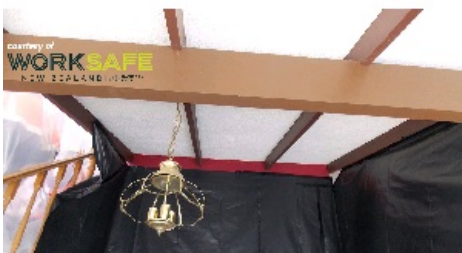
Decorative Ceiling 1-nz.jpg

Name Decorative ceiling

Caption Decorative ceiling with asbestos containing material

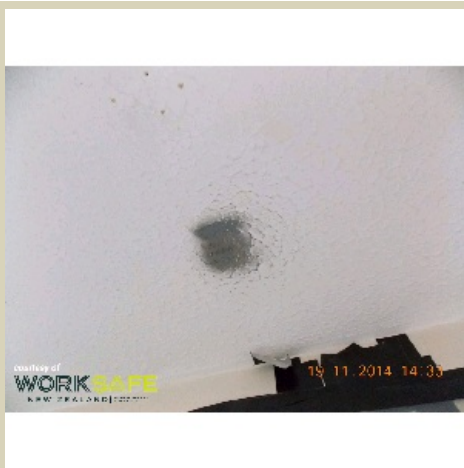
Decorative Ceiling 2 nz.jpg

Name Close up of decorative ceiling

Caption Close up of decorative ceiling with asbestos containing material
