Product: Vinyl floor tiles and covering

Product Name	Vinyl floor tiles and covering
Product type	Floor Covering
Sub-Product type	Floor Tiles
Trading name(s)	
Other name(s)	Floor tiles, vinyl floor, plastic tiles, lino or linoleum.
Product description	Solid, brittle material in a variety of colours used in control rooms, bathrooms, common rooms and amenities rooms of zone substations and Field Service Centres. Sometimes used in bigger distribution substations. Can also be referred to as lino or linoleum.
Build element	Construction
Product identification	
Asbestos-containing vinyl floor tiles can have a variety of colours and shapes, but they will look exactly the same as non-asbestos-containing vinyl floor tiles. Reliable identification can only be achieved by laboratory analysis.	
Known uses	Durable flooring
Asbestos fibre type	Chrysotile (white asbestos)
Friable or Non-Friable	Non-Friable
Known Supplier(s)	
Known place of manufacture	
Date / period of manufacture	Pre 1987

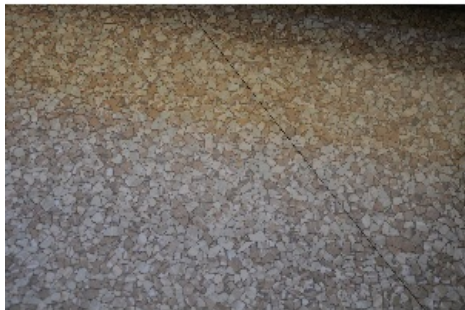
Name Vinyl Floor Covering - Commercial

Caption Commercial Vinyl Floor Covering which contains asbestos in the backing

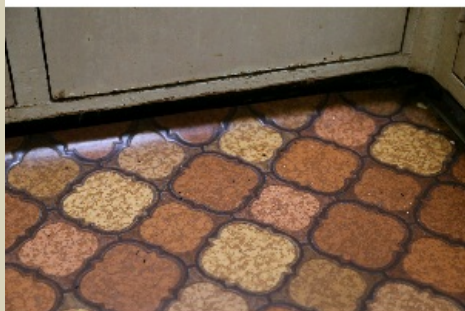
Name Vinyl Floor Covering - Kitchen 1

Caption Domestic vinyl floor covering in a kitchen - it is lifting at the base of the cupboard

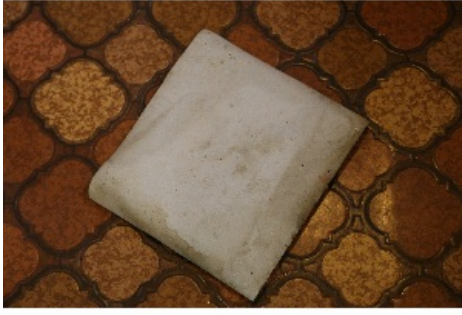
Name Vinyl Floor Covering - Kitchen 1b

Caption Domestic vinyl floor covering in a kitchen and laundry which pictures the underside of a loose section

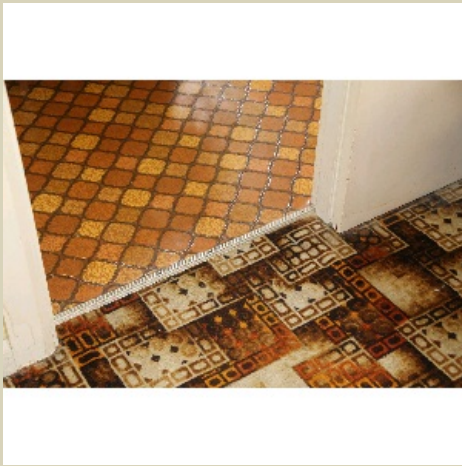
Name Vinyl Floor meets Capet

Caption Domestic vinyl floor covering which meets carpet.

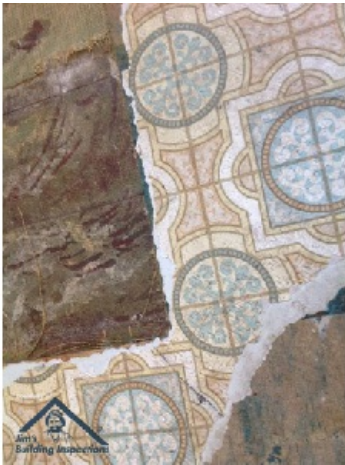
Name Vinyl Floor Covering - Kitchen 2

Caption Domestic vinyl floor covering in a kitchen which has been partially removed exposing asbestos cement floor and adhesive.

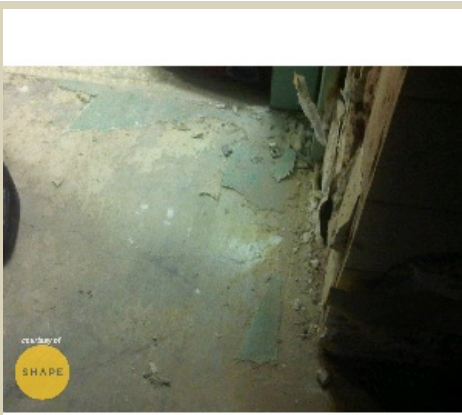
Name	Remnants of Asbestos backed vinyl flooring
Caption	Asbestos backed vinyl sheet flooring. The green material indicates the backing which contains asbestos.
Location	Industrial

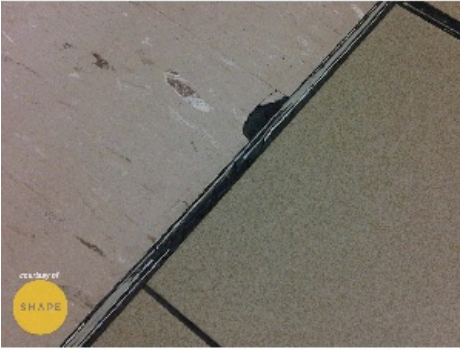
Name Vinyl Floor Covering - Commercial

Caption Vinyl floor tile with backing that contains asbestos.

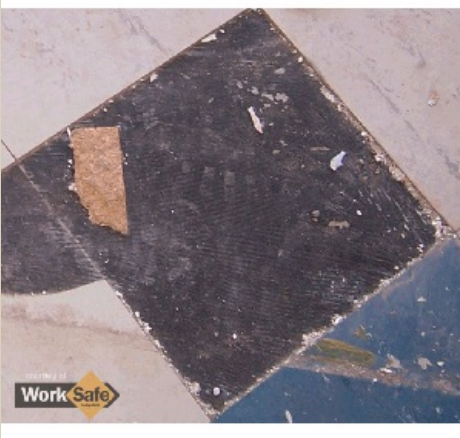
Name Close up Vinyl Floor Covering - Commercial

Caption Asphaltic cutback adhesive under vinyl tiles

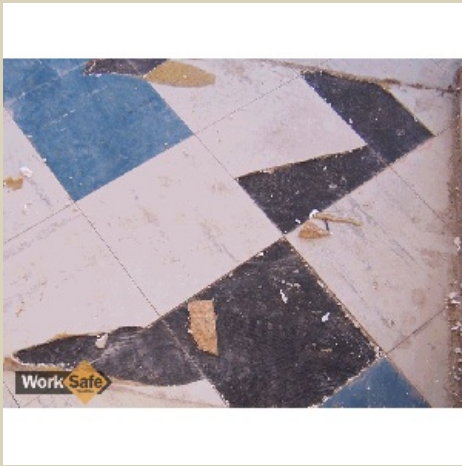
Name	Vinyl Floor Covering
Caption	Asphaltic cutback adhesive under vinyl tiles
Location	Commercial
Source	WorkSafe Tasmania
Image Id	271

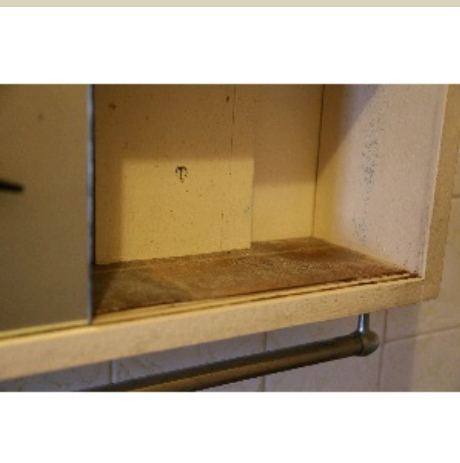
Name	Vinyl flooring as liner
Caption	Vinyl flooring used as shelf liner in bathroom
Location	Domestic home
Source	Asbestos Awareness
Image Id	368

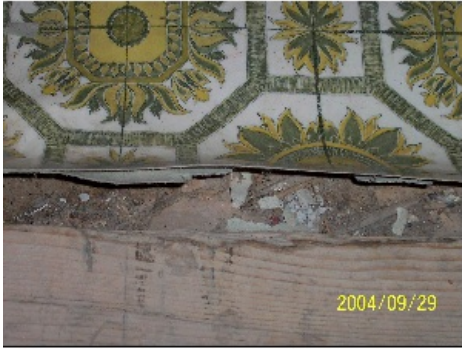
Name	Asbestos paper under lino
Caption	Asbestos paper under lino
Location	Domestic home
Source	Prensa
Image Id	369

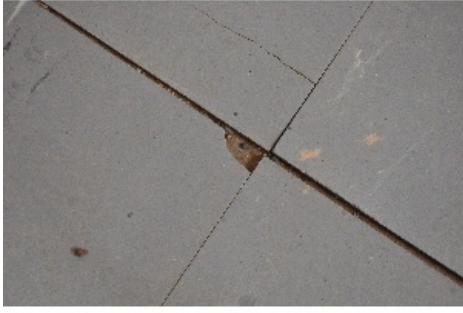
Name	Lino Tiles - lifting
Caption	Commercial lino floor tiles - lifting
Location	Commercial
Source	Asbestos Awareness
Image Id	371

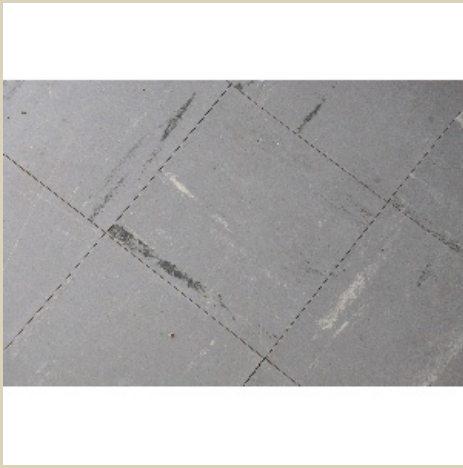
Name	Commercial Lino Tiles
Caption	Commercial lino floor tiles - lifting
Location	Commercial
Source	Asbestos Awareness
Image Id	372
