Product: Vinyl floor tiles and covering

Product Name	Vinyl floor tiles and covering
Product type	Floor Covering
Sub-Product type	Floor Tiles
Trading name(s)	
Other name(s)	Floor tiles, vinyl floor, plastic tiles, lino or linoleum.
Product description	Solid, brittle material in a variety of colours used in control rooms, bathrooms, common rooms and amenities rooms of zone substations and Field Service Centres. Sometimes used in bigger distribution substations. Can also be referred to as lino or linoleum.
Build element	Construction
Product identification	
Asbestos-containing vinyl floor tiles can have a variety of colours and shapes, but they will look exactly the same as non-asbestos-containing vinyl floor tiles. Reliable identification can only be achieved by laboratory analysis.	
Known uses	Durable flooring
Asbestos fibre type	Chrysotile (white asbestos)
Friable or Non-Friable	Non-Friable
Known Supplier(s)	
Known place of manufacture	
Date / period of manufacture	Pre 1987

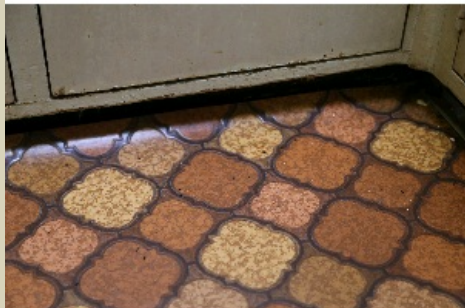
IMG_0103.jpg

Caption Domestic vinyl floor covering in a kitchen - it is lifting at the base of the cupboard

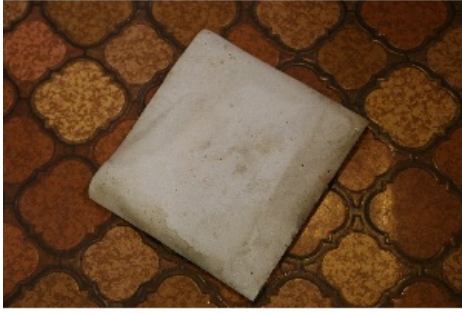
IMG_0124.jpg

Caption Domestic vinyl floor covering in a kitchen and laundry which pictures the underside of a loose section

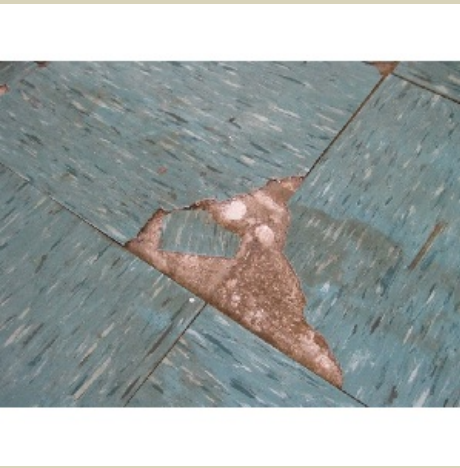
Vinyl floor tiles damaged - photo courtesy of Townsville Asbestos.jpg

Caption Commercial lino floor tiles - damaged

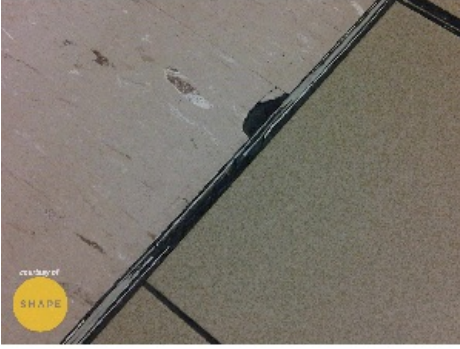
1119.jpg

Caption Vinyl floor tile with backing that contains asbestos.

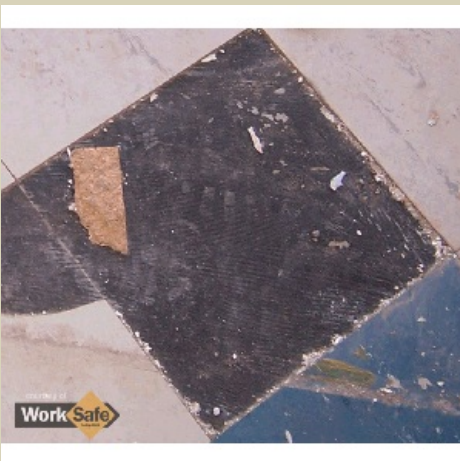
WST_blackjack-glue.jpg

Caption Asphaltic cutback adhesive under vinyl tiles

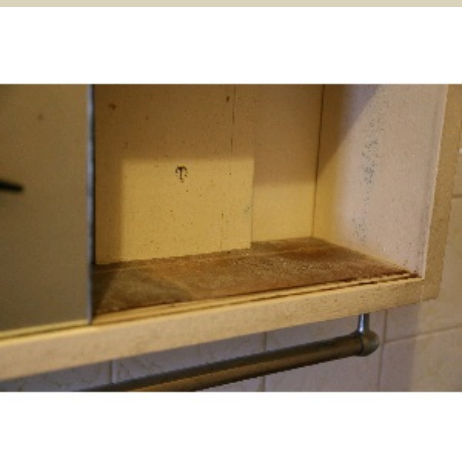
IMG_0502.JPG

Name	Vinyl flooring as liner
Caption	Vinyl flooring used as shelf liner in bathroom
Location	Domestic home
Source	Asbestos Awareness
Image Id	368

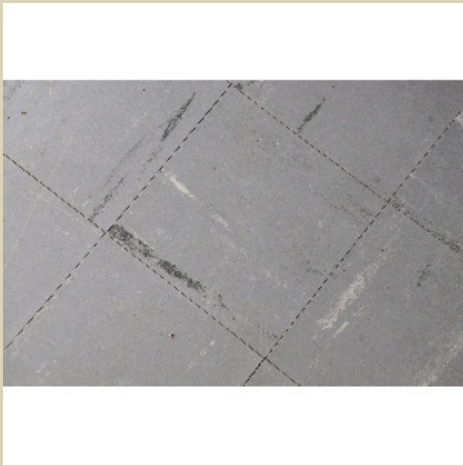
DSC_0161.JPG

Name	Commercial Lino Tiles
Caption	Commercial lino floor tiles - lifting
Location	Commercial
Source	Asbestos Awareness
Image Id	372
