Product: Millboard

Product Name	Millboard
Product type	Insulation boards and blocks (bonded)
Sub-Product type	
Trading name(s)	
Other name(s)	Asbestos board, millboard lining
Product description	<p>Asbestos millboard was used in the construction industry all over the world. Because of its flame-resistant durability it became a popular material to use above fireplaces and stove-tops, as well as other locations in walls and ceilings.</p> <p>Millboard was used in the electricity industry in lining of boxes or interiors of compartments containing heat or spark producing electrical equipment, like relay boxes, contactor boxes. It was also used for lining the inside of wooden outdoor enclosure cabinets or meter boxes.</p> <p>Millboard was also located within the duct work of Air Conditioning re-heating units. This is more specifically located around heating elements.</p>
Build element	Various manufacturing industries requiring boilers or furnaces, air conditioning, construction

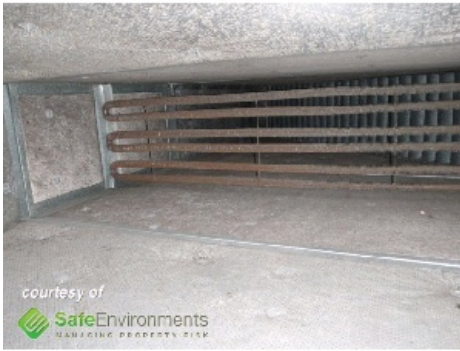
P2030067.jpg

Name Millboard in air conditioning

Caption Asbestos millboard lining which surrounds the air conditioning re-heating elements.

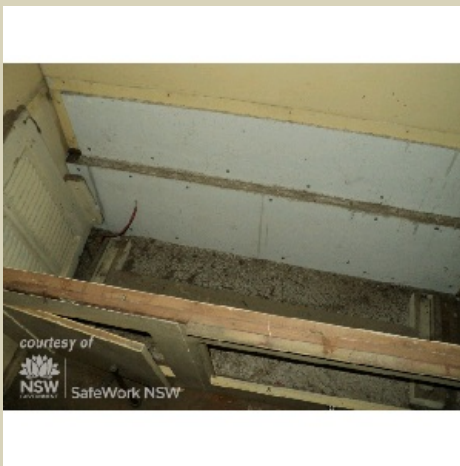
WCNSW_DSC03749.jpg

Name Millboard - Kitchen Wall

Caption Asbestos containing millboard sheeting located in the interior, body wall of a kitchen cooker
