Product: Adhesives and dry powder mixes

| Product type | Adhesives, mastics, putty, sealants, plasters and paints |

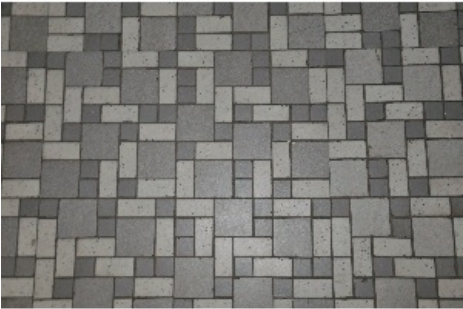
Asbestos Flooring - Tiles-2.jpg

| Name | Bathroom Floor Tiles |
| Caption | Asbestos products used in grout and glue behind tiles |

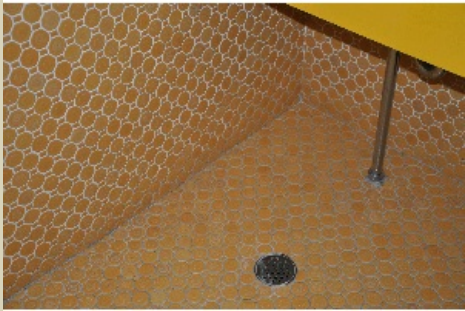
Asbestos Flooring - Tiles-6.jpg

| Name | Bathroom Floor Tiles |
| Caption | Asbestos products used in grout and glue behind tiles |

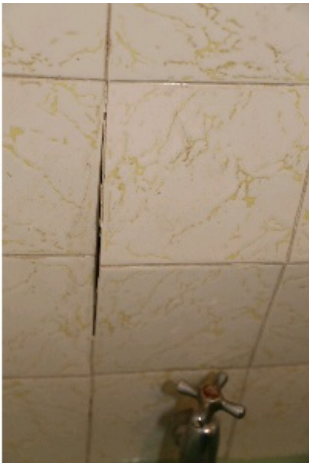
IMG_0144.jpg

| Name | Bathroom Wall Tiles |
| Caption | Asbestos products used in grout and wall behind tiles - tiles are lifting. |

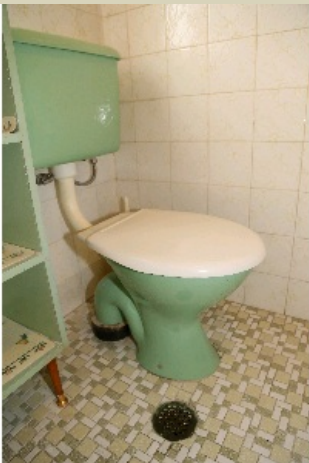
IMG_0146.jpg

| Name | Bathroom wall and floor tiles with toilet |
| Caption | Asbestos products used in grout and wall behind and under floor of tiles |

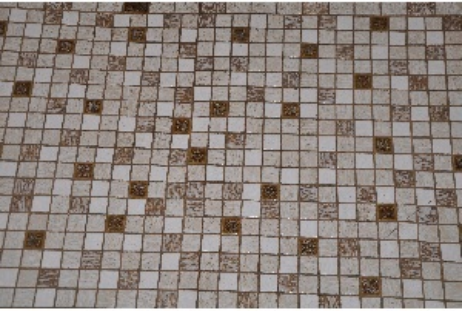
Asbestos Flooring - Tiles-5.jpg

Name Bathroom Floor Tiles

Caption Asbestos products used in grout and glue behind tiles

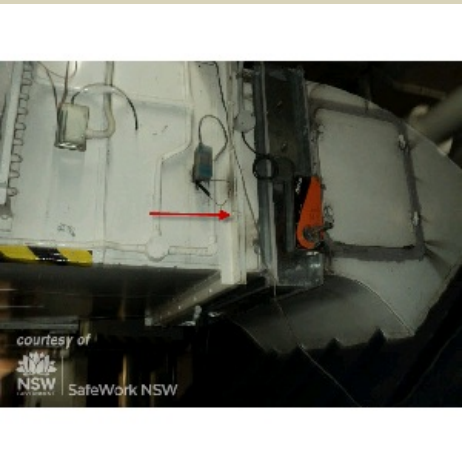
WCNSW_DSC04750 - arrow.jpg

Name Mastic on joints - Plant

Caption Air Conditioning Trunking - asbestos contain mastic to joints.

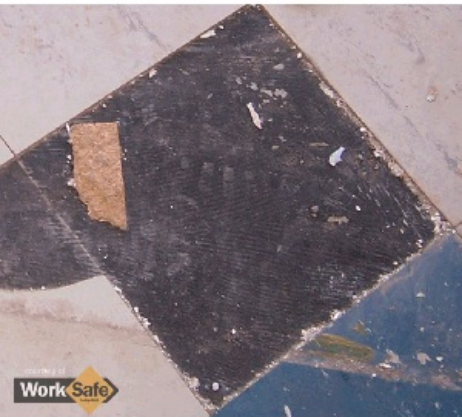
WST_blackjack-glue.jpg

| Name | Asphaltic cutback adhesive |
| Caption | Asphaltic cutback adhesive under vinyl tiles |

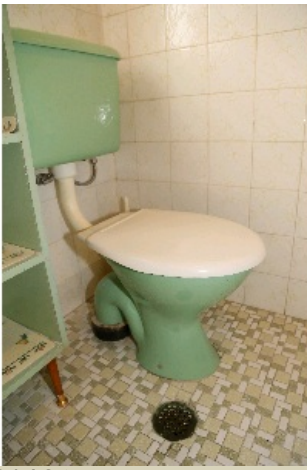
IMG_0146.jpg

| Name | Bathroom Floor and Wall Tiles |
| Caption | Asbestos products used in grout and glue behind tiles |

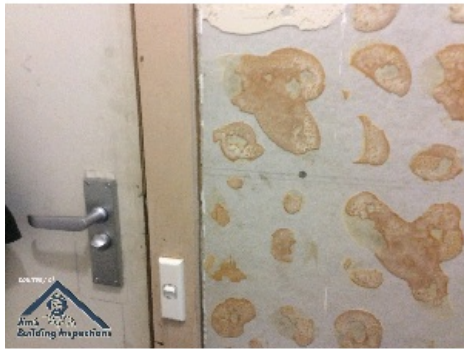
AC Wall behind tiles.jpg

| Name | Bathroom wall - tiles removed |
| Caption | Asbestos cement wall behind tiles with asbestos containing adhesive. |

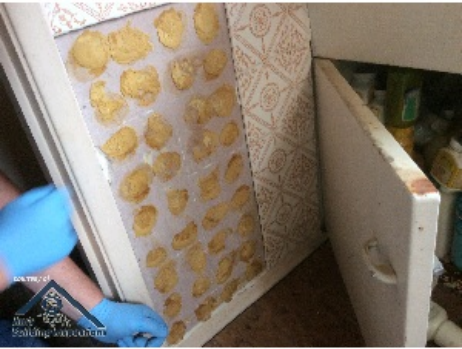
Sheeting behind tiles 2.jpg

| Name | Laundry wall - tiles removed |
| Caption | Asbestos cement wall behind tiles with asbestos containing adhesive. |

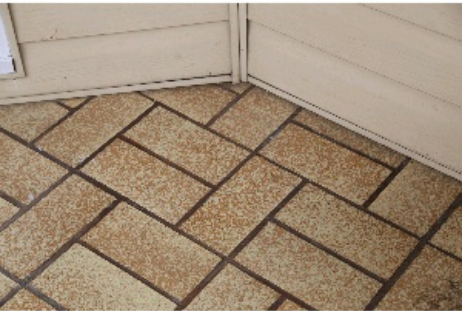
IMG_0182.jpg

| Name | Outdoor Tiles |
| Caption | ACM in adhesive and grout of tile |

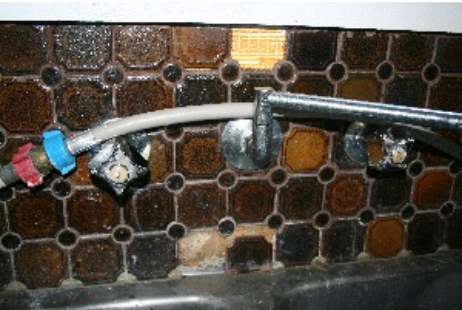
0012AsbestosProduct.JPG

| Name | AC Wall behind tiles and in ACM in grout |
| Caption | Tiles falling off laundry wall expose unsealed asbestos cement sheeting and expose crumbling grout with ACM. |
