Product: Adhesives and dry powder mixes

Product Name	Adhesives and dry powder mixes
Product type	Adhesives, mastics, putty, sealants, plasters and paints
Sub-Product type	
Trading name(s)	
Other name(s)	
Product description	<p>Adhesives, mastics, putty, sealants, plasters and paints are the various types of adhesives known to contain asbestos. They include:</p> <ul style="list-style-type: none"> • Asphaltic cutback adhesive: This is black in colour and is usually found beneath vinyl tiles and flooring. Asbestos was mixed with this product to make it more durable. • Cement adhesive: This is also called furnace cement or stove cement and is a type of joint compound and adhesive used in areas exposed to extreme heat. Furnace cement may be used in boilers, stoves, chimneys, kilns, refractories and manufacturing plants. • Duct adhesive: Commonly available in the form of tape (similar to duct tape) and sprayable adhesive, this product was often used in HVAC systems to prevent cool or warm air from escaping and affecting the temperature of a climate-controlled home or building. • Emulsion adhesive: This is a synthetic form that was used to bond synthetic laminates, like roofing or floor

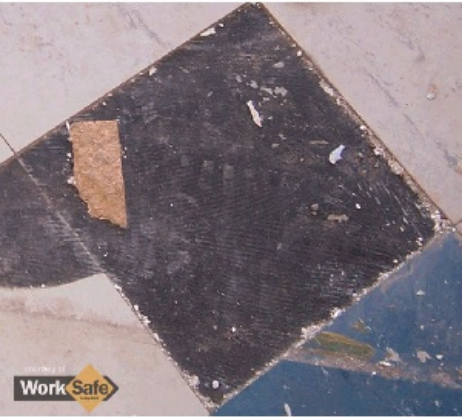
WST_blackjack-glue.jpg

Name	Asphaltic cutback adhesive
Caption	Asphaltic cutback adhesive under vinyl tiles
Location	Commercial
Source	WorkSafe Tasmania
Image Id	112

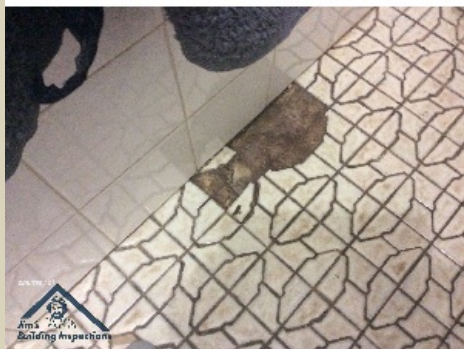
CEMENT FLOORING UNDER TILES.jpg

Name	Bathroom floor - tiles removed
Caption	Asbestos cement floor under tiles with asbestos containing adhesive.
Location	Domestic home
