Product: Corrugated Cement Sheet - Super Six

Product Name	Corrugated Cement Sheet - Super Six
Product type	Cement - sheets, moulded product
Sub-Product type	Fencing & Roofing
Trading name(s)	Super 6 Super Six
Other name(s)	Cement sheets
Product description	Corrugated cement sheets were mainly used for substation roofs, fences, shed walls etc. After prolonged use and weathering they deteriorate and can release asbestos fibres in small quantities which could be deposited near downpipes if they flow to the outside and not to the town sewer.
Build element	Construction
Product identification	
	They are white to grey in colour, hard brittle material, made by James Hardie as a popular brand Super Six. Now days they are replaced with fibre cement materials not containing asbestos of similar appearance.
Known uses	Corrugated fibre cement sheets have been used in Australia for over 40 years in either for fencing or roofing. The original product was an asbestos cement product known as Super Six manufactured by James Hardie & Co. Manufacture ceased in 1985.

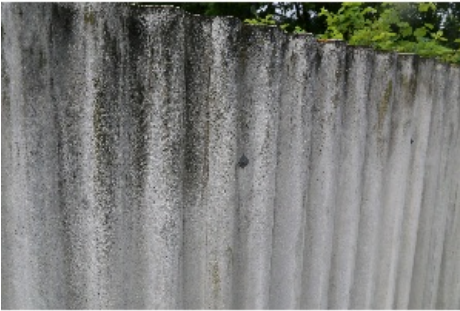
IMG_0303.JPG

Name	Super Six fence
Caption	Super Six corrugated asbestos cement fence
Location	Domestic home
Source	Asbestos Education Committee
Image Id	139

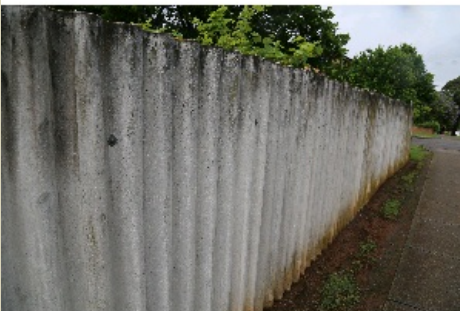
IMG_0305.JPG

Name	Super Six fence
Caption	Super Six corrugated asbestos cement fence
Location	Commercial
Source	Asbestos Education Committee
Image Id	140

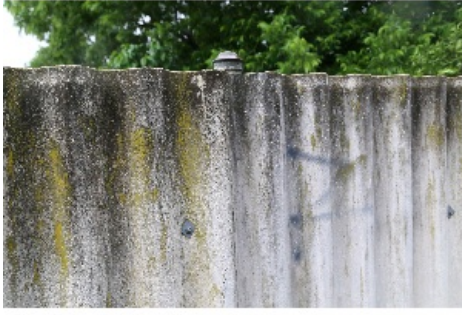
IMG_0314.JPG

Name Super Six fence - close up

Caption Close up of Super Six corrugated asbestos cement fence with diamond washer/nut & bolt fixing visible.

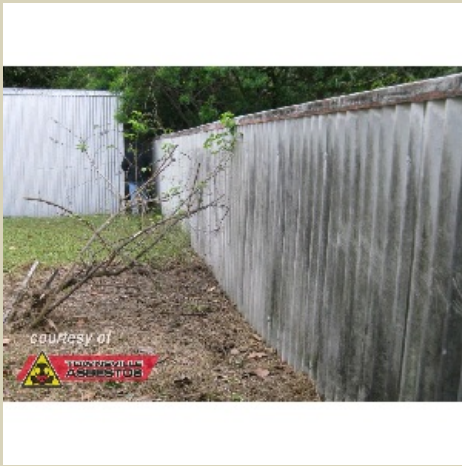
Fence 2.jpg

Name Super Six fence - with ridge capping

Caption Super Six fence - with asbestos cement ridge capping

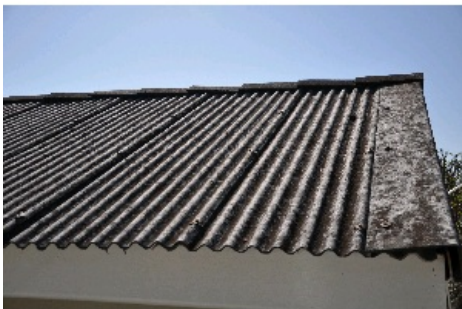
0055AsbestosProduct.JPG

Name Super Six Roof, flashing and ridge capping

Caption Super Six Roof, corrugated asbestos cement with asbestos cement flashing and ridge capping

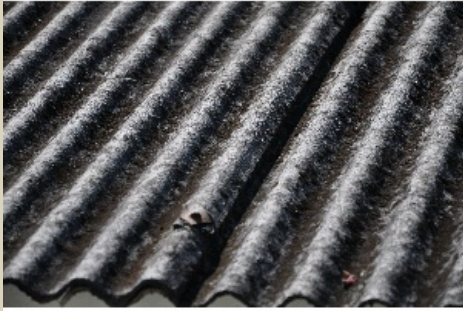
0058AsbestosProduct.JPG

Name Super Six Roof

Caption Close up of super Six Roof, corrugated asbestos cement

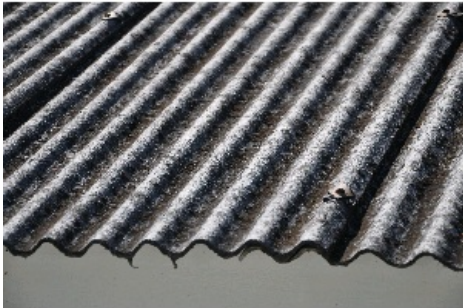
0059AsbestosProduct.JPG

Name Super Six Roof

Caption Close up of super Six Roof, corrugated asbestos cement

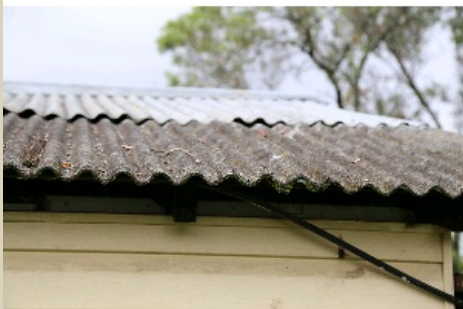
IMG_0224.JPG

Name Super Six and Tin Roof

Caption Garage roof with original Super Six corrugated asbestos cement with upper rake made of tin

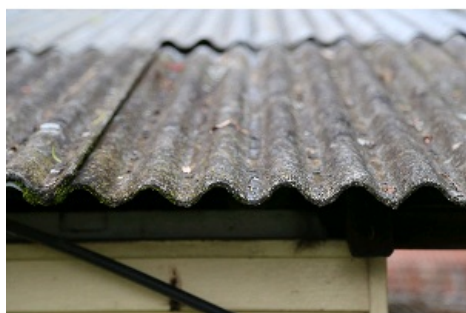
IMG_0227.JPG

Name Super Six and Tin Roof

Caption Garage roof with original Super Six corrugated asbestos cement with upper rake made of tin - close up

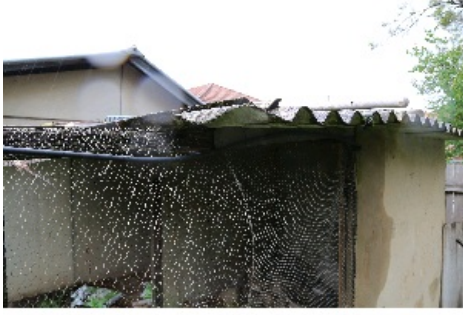
IMG_0237.JPG

Name	Super Six Aviary Roof
Caption	Roof of an aviary made of Super Six corrugated asbestos cement
Location	Domestic home
Source	Asbestos Education Committee
Image Id	149

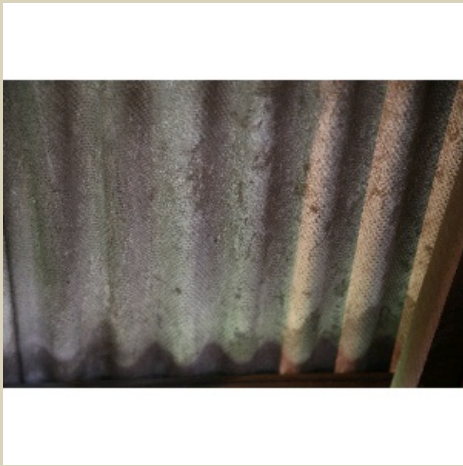
IMG_0259.JPG

Name	Underside of Super Six
Caption	Underside of Super Six corrugated asbestos cement roof - dimple texture visible
Location	Domestic home
Source	Asbestos Education Committee
Image Id	150

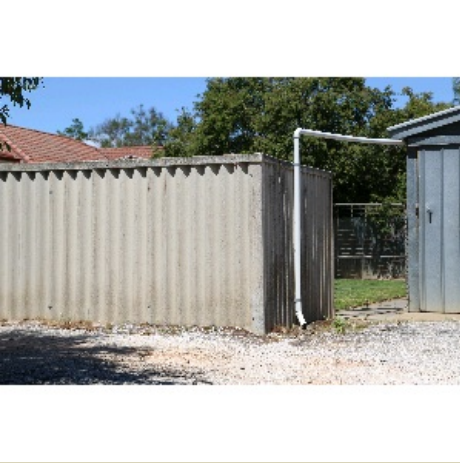
Fencing with capping 2527 Courtesy of Asbestos Awareness.JPG

Name Fencing with AC capping

Caption Corrugated Asbestos Cement Super 6 Fence with Capping

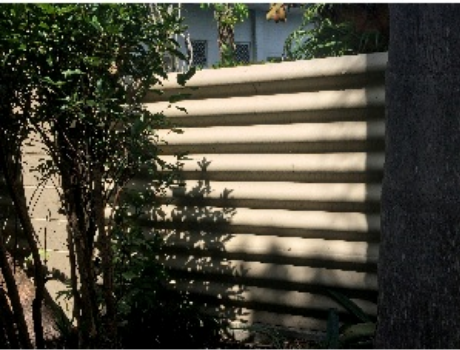
Super Six fencing 419.JPG

Name Horizontal Super 6 Fence

Caption Horizontal Corrugated Asbestos Cement Super 6 Fence
