## Product: Fire Doors

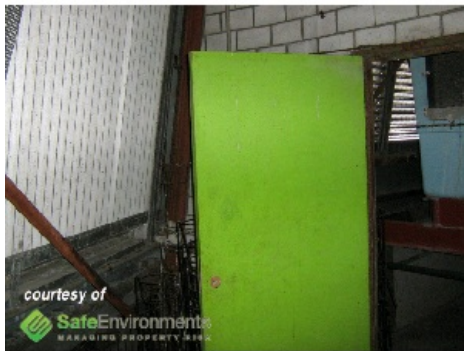
img-3196.jpg

<b>Name</b>	Internal fire door
<b>Caption</b>	Fire door located in a plant room to a commercial sky scraper
<b>Location</b>	Commercial
<b>Source</b>	Safe Environments
<b>Image Id</b>	115

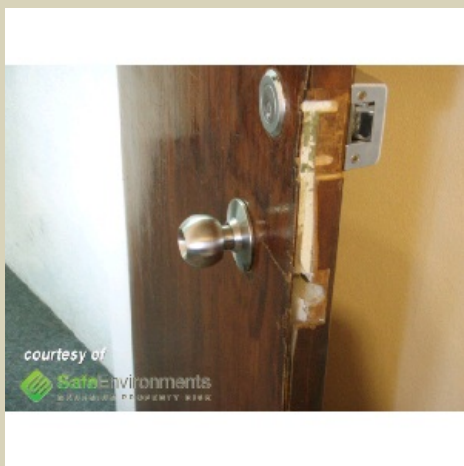
P2170078.jpg

<b>Name</b>	Internal fire door
<b>Caption</b>	Fire door from a block of residential units / apartments
<b>Location</b>	Domestic home
<b>Source</b>	Safe Environements
<b>Image Id</b>	116

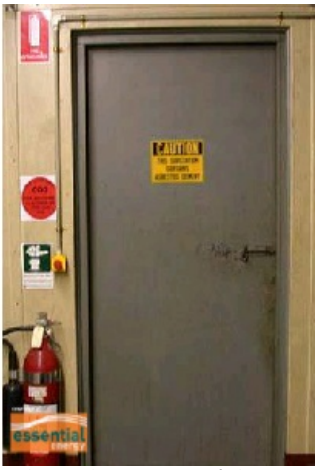
Substation Fire Doors 1.jpg

**Name** Substation fire door

**Caption** Substation fire door with asbestos containing insulation

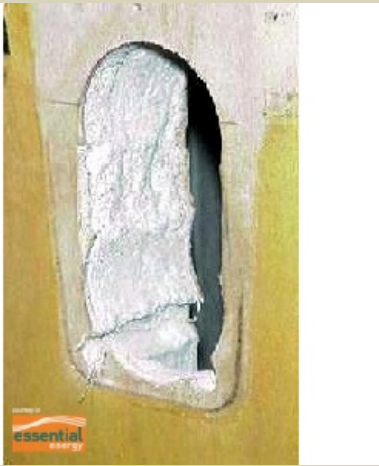
Substation Fire Doors - 2.jpg

**Name** Close Up Substation Fire Door - exposed

**Caption** Close up of exposed internal asbestos insulation within fire door.
