## Product: Tilux - Wet-area fibrous asbestos cement sheet

<b>Product Name</b>	Tilux - Wet-area fibrous asbestos cement sheet
<b>Product type</b>	Cement - sheets, moulded product
<b>Sub-Product type</b>	
<b>Trading name(s)</b>	Tilux
<b>Other name(s)</b>	
<b>Product description</b>	Compressed and autoclaved, coloured and patterned waterproof cement sheeting, used mainly in kitchens, bathrooms and laundries
<b>Build element</b>	Construction
<b>Product identification</b>	
<p>Tilux sheets were attached to walls and used as splashbacks in bathrooms and kitchens, as shower recesses and bathroom walls. The stainless steel strip between sheets is a primary indicator. The sheets were patterned and often in shades of pink, blue, green and grey. The surface is coated and can be a dull matt appearance or shiny.</p>	
<b>Known uses</b>	Wall lining or tiling in kitchens, bathrooms and laundries
<b>Asbestos fibre type</b>	Amosite (brown asbestos) Chrysotile (white asbestos) Crocidolite (blue asbestos)

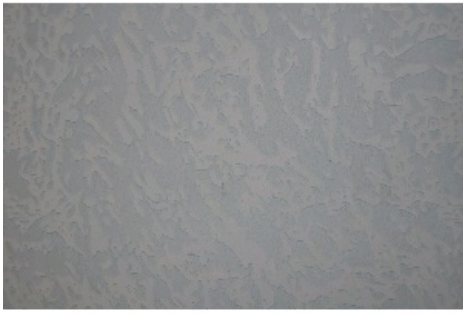
0062AsbestosProduct.JPG

<b>Name</b>	Tilux 1
<b>Caption</b>	Close up of Tilux on partition wall
<b>Location</b>	Domestic home
<b>Source</b>	Asbestos Education Committee
<b>Image Id</b>	170

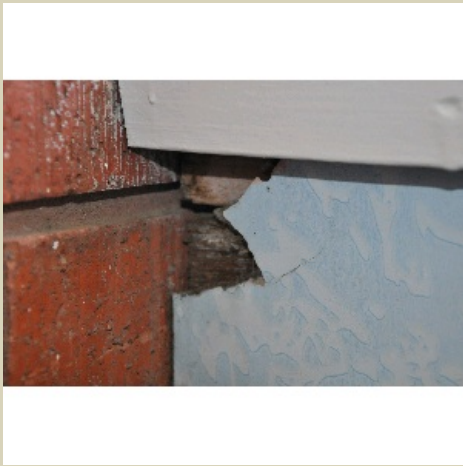
0067AsbestosProduct.JPG

<b>Name</b>	Tilux - damaged
<b>Caption</b>	Close up of damaged section of Tilux from a laundry. The broken corner exposes the fibres.
<b>Location</b>	
<b>Source</b>	Asbestos Education Committee
<b>Image Id</b>	171

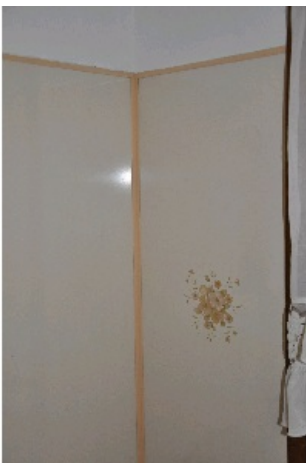
0093AsbestosProduct.JPG

<b>Name</b>	Asbestos cement wall behind Tilux
<b>Caption</b>	Asbestos cement wall behind Tilux
<b>Location</b>	Domestic home

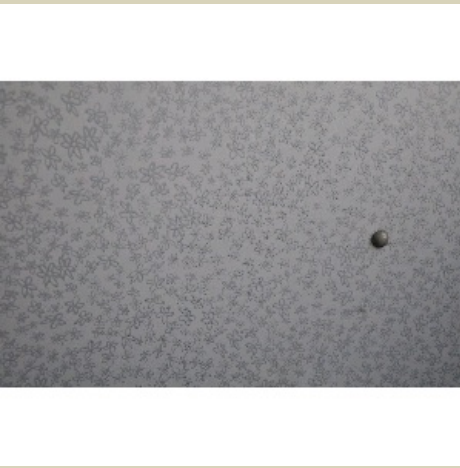
TILUX\_0093.JPG

**Name** Tilux - Springtime Blue Close Up

**Caption** Close up photo of Tilux in Springtime Blue pattern. The silver screw holding it to the wall, visible in this photo, is an indicator that the material you have may be asbestos containing Tilux.

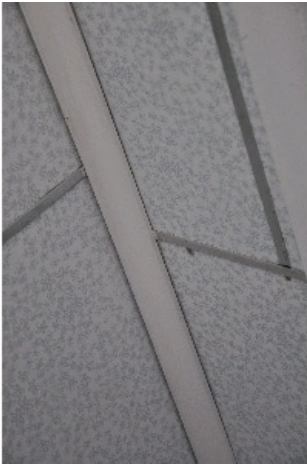
TILUX\_0094.JPG

**Name** Tilux - Springtime Blue Joins

**Caption** Tilux in Springtime Blue pattern. The silver metal cover strips, visible in this photo, indicate the material would be Tilux.

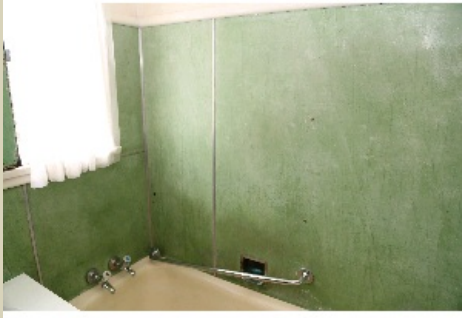
IMG\_0077.JPG

**Name** Tilux walls - Hazard

**Caption** The Tilux in this bathroom is a hazard. Due to years of scrubbing, the outer sealed layer has been cleaned off creating fine dust which would contain asbestos.

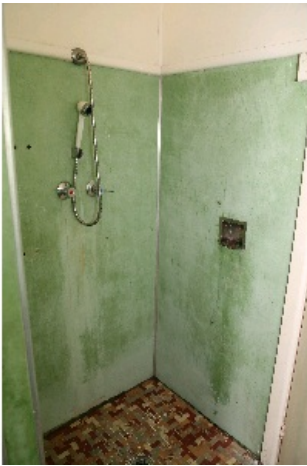
IMG\_0083.JPG

**Name** Tilux Shower and Asbestos

**Caption** The Tilux in this bathroom is a hazard. Due to years of scrubbing, the outer sealed layer has been cleaned off creating a fine dust which would contain asbestos. The upper walls are also asbesto cement, the flooring beneath the tiles and the grout also contain asbestos containing materials.

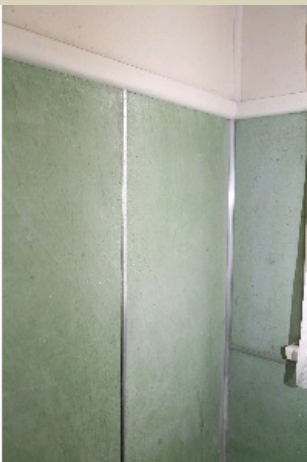
IMG\_0085.JPG

<b>Name</b>	Tilux bathroom walls - hazard
<b>Caption</b>	The Tilux in this bathroom is a hazard. Due to years of scrubbing, the outer sealed layer has been cleaned off creating fine dust which would contain asbestos.
<b>Location</b>	Domestic home
<b>Source</b>	Asbestos Education Committee
<b>Image Id</b>	178

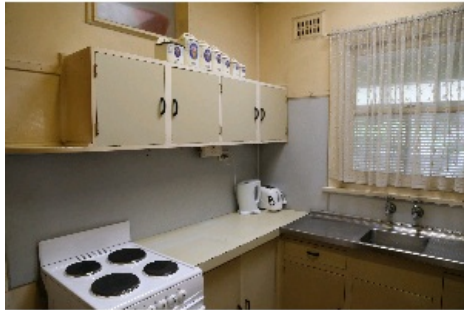
IMG\_0092.JPG

<b>Name</b>	Tilux kitchen splash back
<b>Caption</b>	Well maintained Tilux sheeting used as a kitchen splash back.
<b>Location</b>	Domestic home
<b>Source</b>	Asbestos Education Committee
<b>Image Id</b>	179

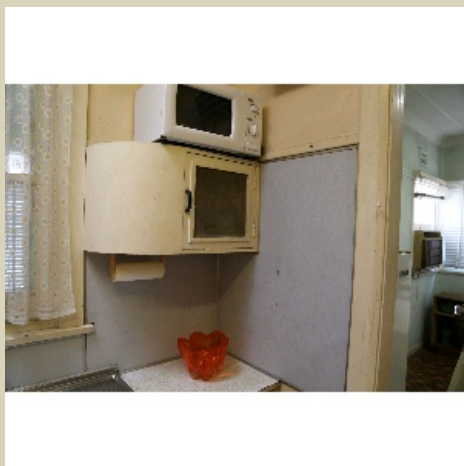
IMG\_0093.JPG

<b>Name</b>	Tilux kitchen splash back
<b>Caption</b>	Well maintained Tilux sheeting used as a kitchen splash-back. Tilux has been cut to accommodate cupboards.
<b>Location</b>	Domestic home
<b>Source</b>	Asbestos Education Committee
<b>Image Id</b>	180

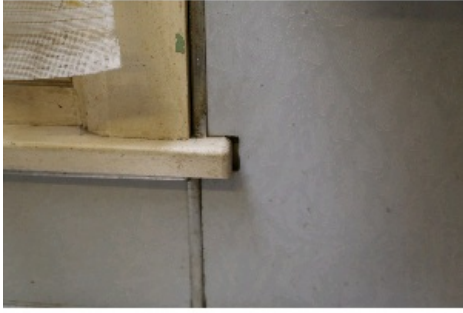
IMG\_0108.JPG

**Name** Tilux kitchen splashback - lose up

**Caption** Tilux sheeting used as a kitchen splash back. Tilux has been cut around the window creating an exposed gap..

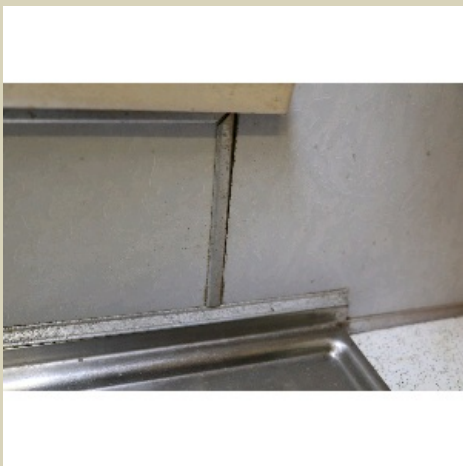
IMG\_0109.JPG

**Name** Tilux kitchen splashback

**Caption** Tilux sheeting used as a kitchen splash back. The silver metal cover strips, visible in this photo, indicate the material would be Tilux.

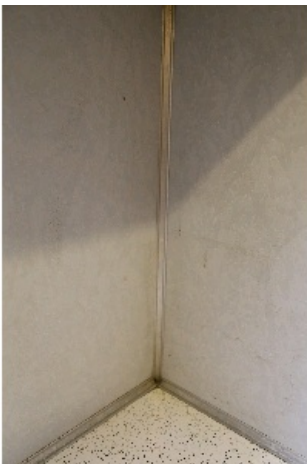
IMG\_0110.JPG

**Name** Tilux kitchen splashback and laminate bench

**Caption** The silver metal cover strips, visible in this photo, indicate the material would be Tilux. The glue under the laminate bench top may contain asbestos.

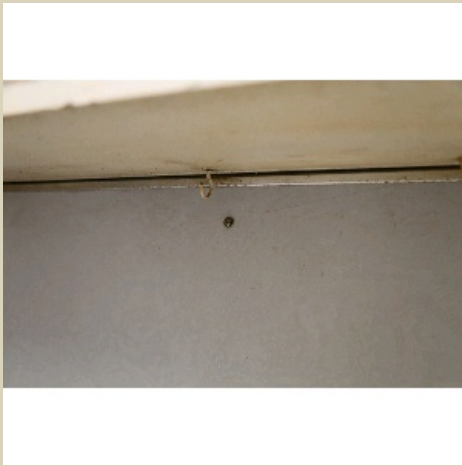
IMG\_0111.JPG

**Name** Tilux kitchen splashback

**Caption** The silver metal cover strips and metal screw visible in this photo, indicate the material would be Tilux.

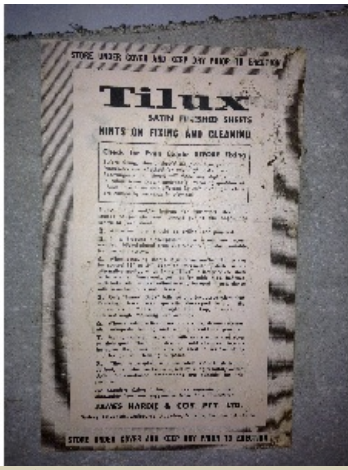
image.jpeg

**Name** Tilux - original label

**Caption** Original Tilux instruction sheet attached to back of Tilux wall sheet

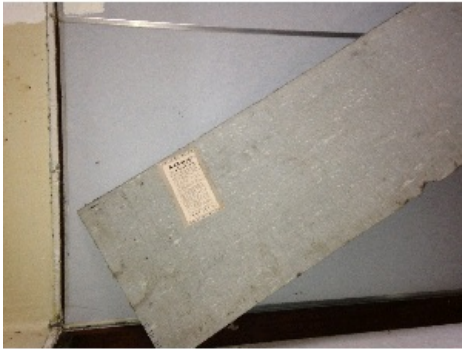
tilux 2.jpeg

**Name** Tilux with original label

**Caption** Original Tilux instruction sheet attached to back of Tilux wall sheet
