Product: Tilux - Wet-area fibrous asbestos cement sheet

Product Name	Tilux - Wet-area fibrous asbestos cement sheet
Product type	Cement - sheets, moulded product
Sub-Product type	
Trading name(s)	Tilux
Other name(s)	
Product description	Compressed and autoclaved, coloured and patterned waterproof cement sheeting, used mainly in kitchens, bathrooms and laundries
Build element	Construction
Product identification	
Tilux sheets were attached to walls and used as splashbacks in bathrooms and kitchens, as shower recesses and bathroom walls. The stainless steel strip between sheets is a primary indicator. The sheets were patterned and often in shades of pink, blue, green and grey. The surface is coated and can be a dull matt appearance or shiny.	
Known uses	Wall lining or tiling in kitchens, bathrooms and laundries
Asbestos fibre type	Amosite (brown asbestos) Chrysotile (white asbestos) Crocidolite (blue asbestos)
Friable or Non-Friable	Non-Friable
Known Supplier(s)	James Hardie

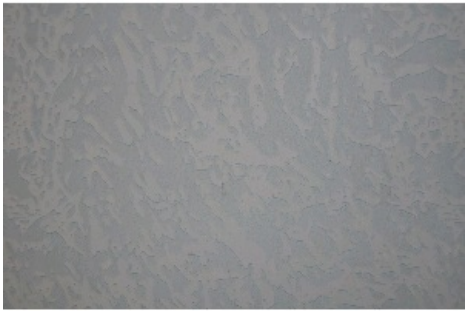
0062AsbestosProduct.JPG

Name	Tilux 1
Caption	Close up of Tilux on partition wall
Location	Domestic home
Source	Asbestos Education Committee
Image Id	170

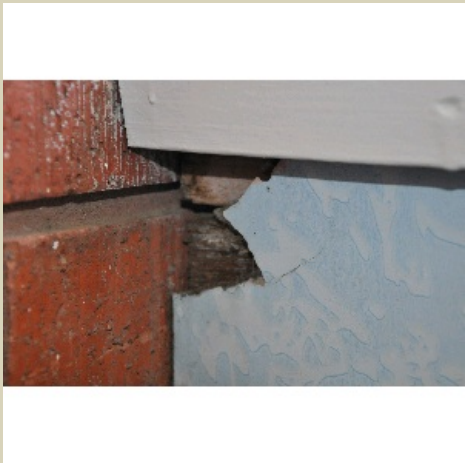
0067AsbestosProduct.JPG

Name	Tillux - damaged
Caption	Close up of damaged section of Tilux from a laundry. The broken corner exposes the fibres.
Location	
Source	Asbestos Education Committee
Image Id	171

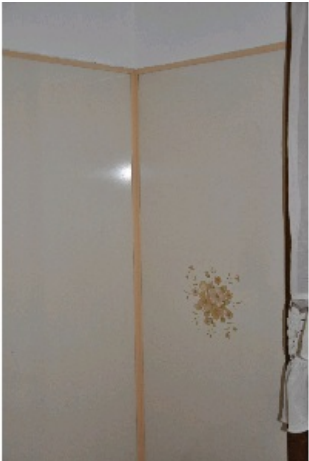
0093AsbestosProduct.JPG

Name	Asbestos cement wall behind Tilux
Caption	Asbestos cement wall behind Tilux
Location	Domestic home

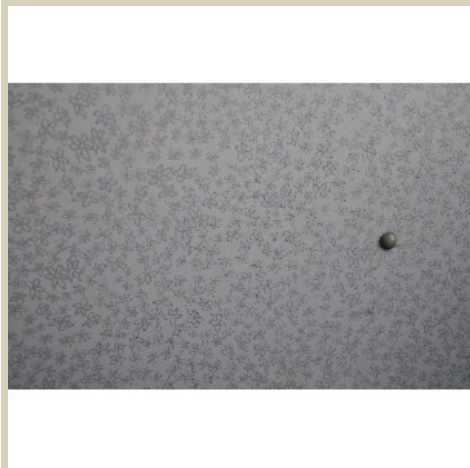
TILUX_0093.JPG

Name	Tilux - Springtime Blue Close Up
Caption	Close up photo of Tilux in Springtime Blue pattern. The silver screw holding it to the wall, visible in this photo, is an indicator that the material you have may be asbestos containing Tilux.
Location	Domestic home
Source	Asbestos Education Committee
Image Id	173

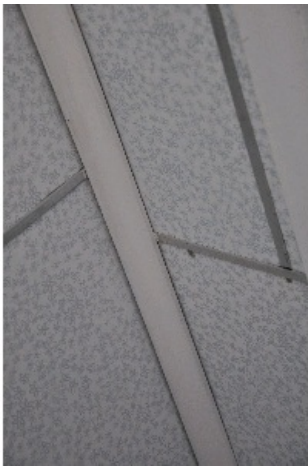
TILUX_0094.JPG

Name	Tilux - Springtime Blue Joins
Caption	Tilux in Springtime Blue pattern. The silver metal cover strips, visible in this photo, indicate the material would be Tilux.
Location	Domestic home
Source	Asbestos Education Committee
Image Id	174

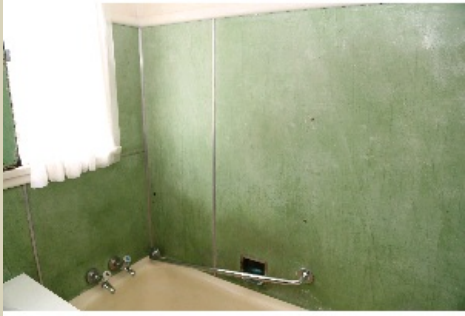
IMG_0077.JPG

Name	Tilux walls - Hazard
Caption	The Tilux in this bathroom is a hazard. Due to years of scrubbing, the outer sealed layer has been cleaned off creating fine dust which would contain asbestos.
Location	Domestic home
Source	Asbestos Education Committee
Image Id	176

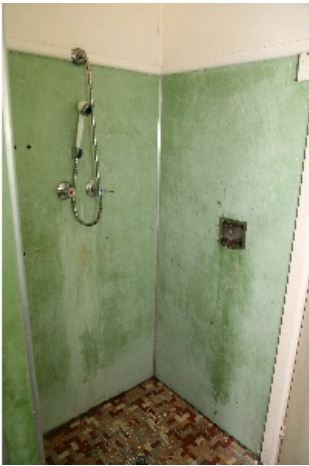
IMG_0083.JPG

Name	Tilux Shower and Asbestos
Caption	The Tilux in this bathroom is a hazard. Due to years of scrubbing, the outer sealed layer has been cleaned off creating a fine dust which would contain asbestos. The upper walls are also asbesto cement, the flooring beneath the tiles and the grout also contain asbestos containing materials.
Location	Domestic home
Source	Asbestos Education Committee
Image Id	177

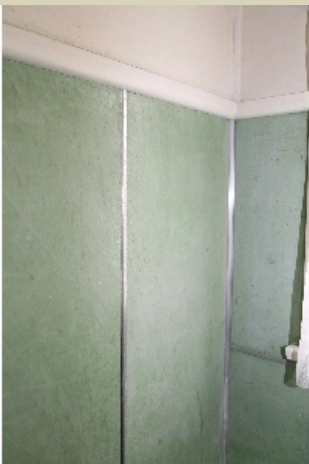
IMG_0085.JPG

Name	Tilux bathroom walls - hazard
Caption	The Tilux in this bathroom is a hazard. Due to years of scrubbing, the outer sealed layer has been cleaned off creating fine dust which would contain asbestos.
Location	Domestic home
Source	Asbestos Education Committee
Image Id	178

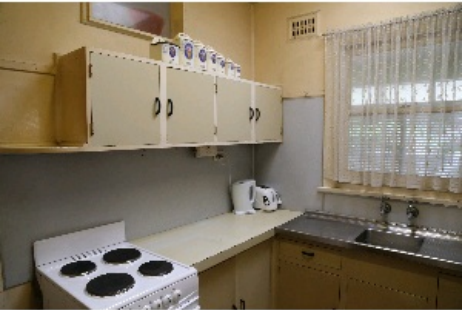
IMG_0092.JPG

Name	Tilux kitchen splash back
Caption	Well maintained Tilux sheeting used as a kitchen splash back.
Location	Domestic home
Source	Asbestos Education Committee
Image Id	179

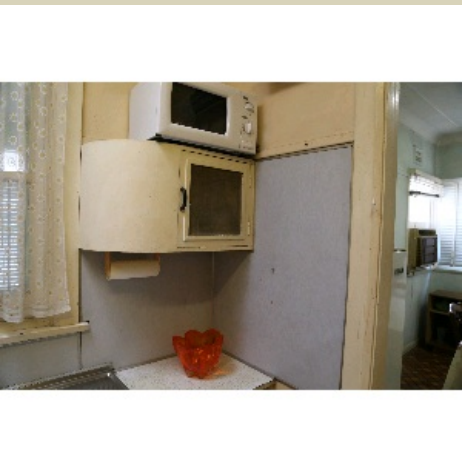
IMG_0093.JPG

Name	Tilux kitchen splash back
Caption	Well maintained Tilux sheeting used as a kitchen splash-back. Tilux has been cut to accommodate cupboards.
Location	Domestic home
Source	Asbestos Education Committee
Image Id	180

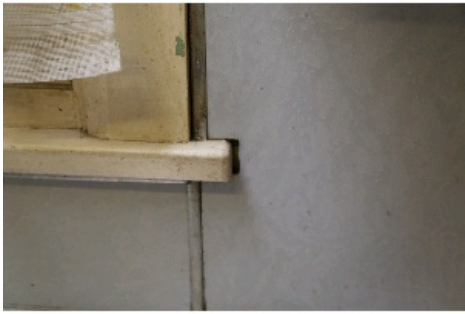
IMG_0108.JPG

Name	Tilux kitchen splashback - lose up
Caption	Tilux sheeting used as a kitchen splash back. Tilux has been cut around the window creating an exposed gap..
Location	Domestic home
Source	Asbestos Education Committee
Image Id	181

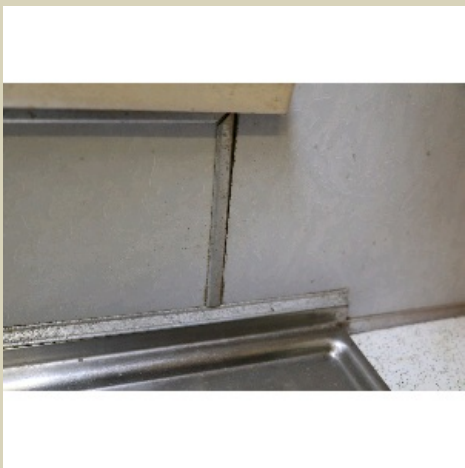
IMG_0109.JPG

Name	Tilux kitchen splashback
Caption	Tilux sheeting used as a kitchen splash back. The silver metal cover strips, visible in this photo, indicate the material would be Tilux.
Location	Domestic home
Source	Asbestos Education Committee
Image Id	182

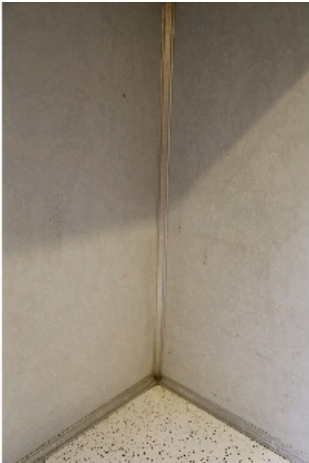
IMG_0110.JPG

Name	Tilux kitchen splashback and laminate bench
Caption	The silver metal cover strips, visible in this photo, indicate the material would be Tilux. The glue under the laminate bench top may contain asbestos.
Location	Domestic home
Source	Asbestos Education Committee
Image Id	183

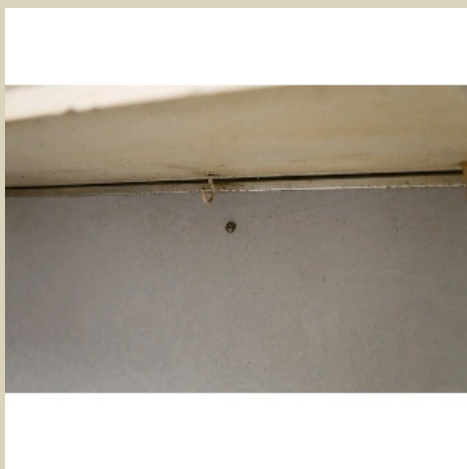
IMG_0111.JPG

Name	Tilux kitchen splashback
Caption	The silver metal cover strips and metal screw visible in this photo, indicate the material would be Tilux.
Location	Domestic home
Source	Asbestos Education Committee
Image Id	184

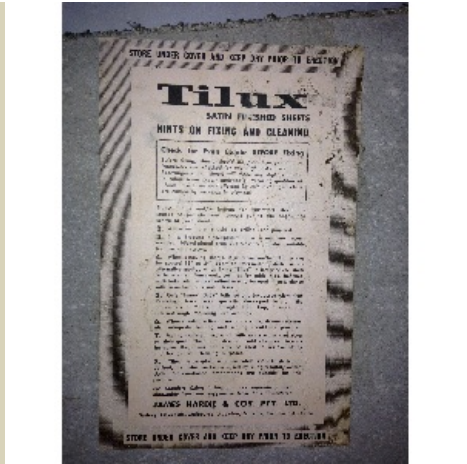
image.jpeg

Name	Tilux - original label
Caption	Original Tilux instruction sheet attached to back of Tilux wall sheet
Location	Domestic home
Source	Asbestos Awareness
Image Id	327

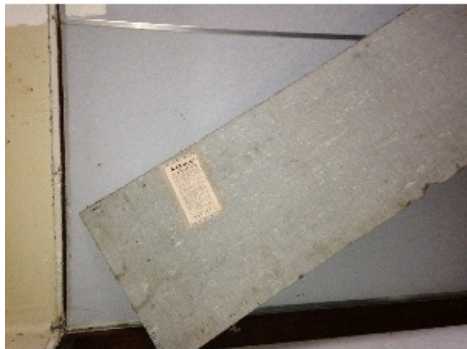
tilux 2.jpeg

Name	Tilux with original label
Caption	Original Tilux instruction sheet attached to back of Tilux wall sheet
Location	Domestic home
Source	Asbestos Awareness
Image Id	328
