## Product: Tilux - Wet-area fibrous asbestos cement sheet

<b>Product Name</b>	Tilux - Wet-area fibrous asbestos cement sheet
<b>Product type</b>	Cement - sheets, moulded product
<b>Sub-Product type</b>	
<b>Trading name(s)</b>	Tilux
<b>Other name(s)</b>	
<b>Product description</b>	Compressed and autoclaved, coloured and patterned waterproof cement sheeting, used mainly in kitchens, bathrooms and laundries
<b>Build element</b>	Construction
<b>Product identification</b>	
<p>Tilux sheets were attached to walls and used as splashbacks in bathrooms and kitchens, as shower recesses and bathroom walls. The stainless steel strip between sheets is a primary indicator. The sheets were patterned and often in shades of pink, blue, green and grey. The surface is coated and can be a dull matt appearance or shiny.</p>	
<b>Known uses</b>	Wall lining or tiling in kitchens, bathrooms and laundries
<b>Asbestos fibre type</b>	Amosite (brown asbestos) Chrysotile (white asbestos) Crocidolite (blue asbestos)

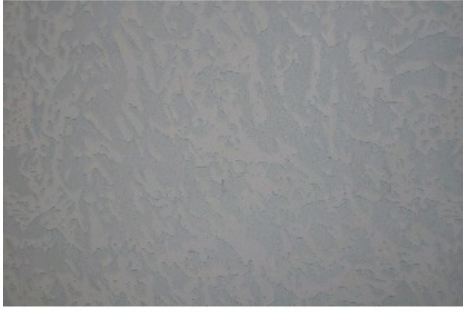
0062AsbestosProduct.JPG

<b>Name</b>	Tilux 1
<b>Caption</b>	Close up of Tilux on partition wall
<b>Location</b>	Domestic home
<b>Source</b>	Asbestos Education Committee
<b>Image Id</b>	170

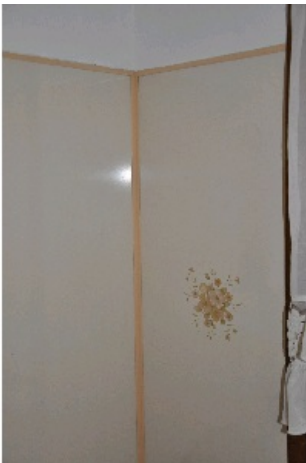
0093AsbestosProduct.JPG

<b>Name</b>	Asbestos cement wall behind Tilux
<b>Caption</b>	Asbestos cement wall behind Tilux
<b>Location</b>	Domestic home

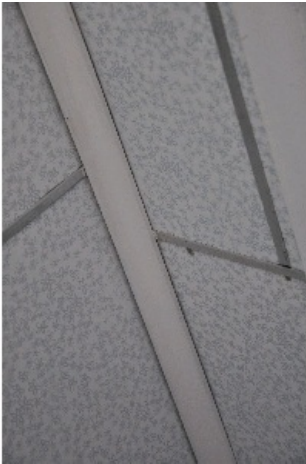
TILUX\_0094.JPG

**Name** Tilux - Springtime Blue Joins

**Caption** Tilux in Springtime Blue pattern. The silver metal cover strips, visible in this photo, indicate the material would be Tilux.

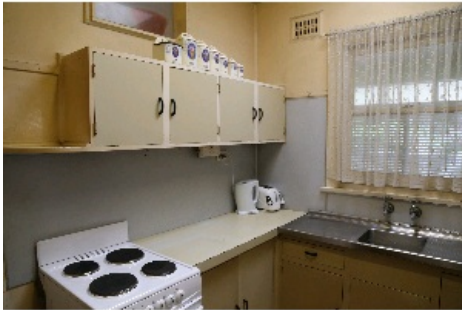
IMG\_0092.JPG

**Name** Tilux kitchen splash back

**Caption** Well maintained Tilux sheeting used as a kitchen splash back.

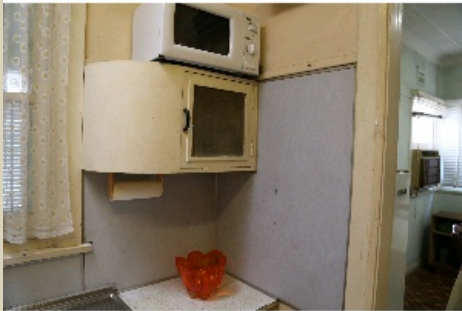
IMG\_0093.JPG

**Name** Tilux kitchen splash back

**Caption** Well maintained Tilux sheeting used as a kitchen splash-back. Tilux has been cut to accommodate cupboards.

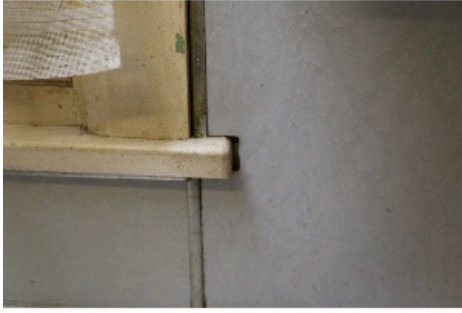
IMG\_0108.JPG

**Name** Tilux kitchen splashback - lose up

**Caption** Tilux sheeting used as a kitchen splash back. Tilux has been cut around the window creating an exposed gap..

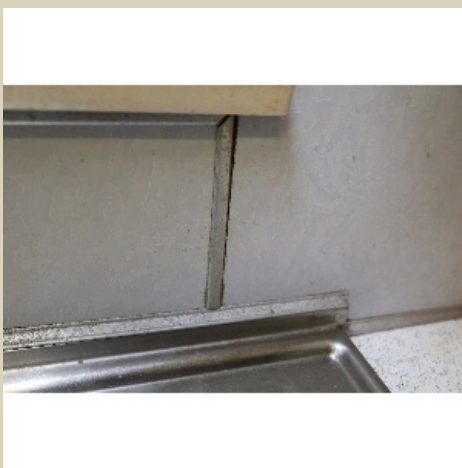
IMG\_0109.JPG

**Name** Tilux kitchen splashback

**Caption** Tilux sheeting used as a kitchen splash back. The silver metal cover strips, visible in this photo, indicate the material would be Tilux.

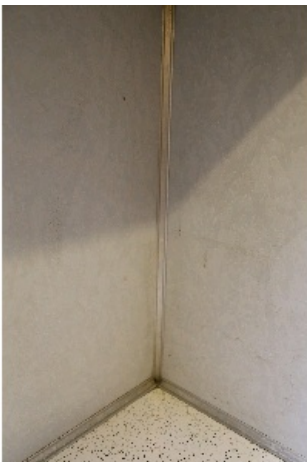
IMG\_0110.JPG

**Name** Tilux kitchen splashback and laminate bench

**Caption** The silver metal cover strips, visible in this photo, indicate the material would be Tilux. The glue under the laminate bench top may contain asbestos.

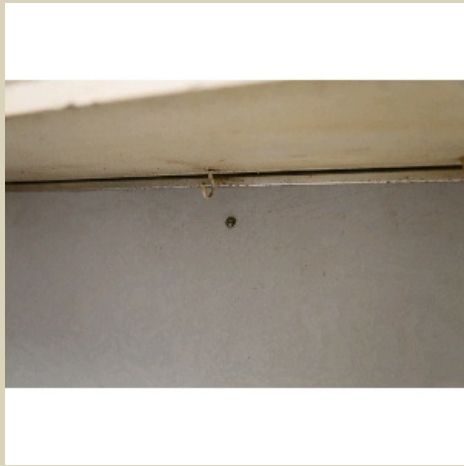
IMG\_0111.JPG

**Name** Tilux kitchen splashback

**Caption** The silver metal cover strips and metal screw visible in this photo, indicate the material would be Tilux.
