Product: Door, Window, Cornice & Joining Strip Mouldings

Product Name	Door, Window, Cornice & Joining Strip Mouldings
Product type	Asbestos Cement Fixings
Sub-Product type	
Trading name(s)	
Other name(s)	architrave
Product description	Used as architrave around doors and windows, window sills also used a AC sheet joining strips can have plain or spigoted ends, including louvre blades, also used as cornices. A round nail can be visible on the strip, usually just above surface. Commonly used as joining strips, window and door architrave.
Build element	Construction
Product identification	
	Round nail visible on the strip, usually just above surface. Commonly used as joining strips, window and door architrave.
Known uses	Commonly used as joining strips, cornices, window and door architrave.
Asbestos fibre type	Chrysotile (white asbestos)
Friable or Non-Friable	Non-Friable
Known Supplier(s)	James Hardie
Known place of manufacture	
Date / period of manufacture	
Building construction period	1900-1920,1921-1930,1931-1940,1941-1950,1951-1960,1961-1970,1970-1980,1981-1990,Pre 1900

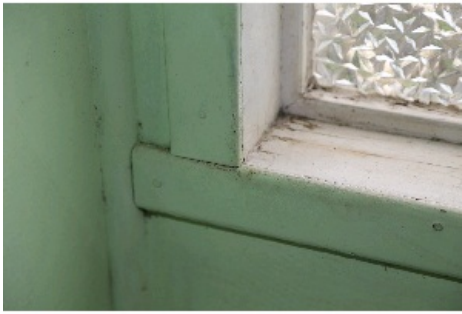
IMG_0130.jpg

Name	Asbestos window trim
Caption	Window architrave made from moulded asbestos cement
Location	Domestic home
Source	Asbestos Education Committee
Image Id	46

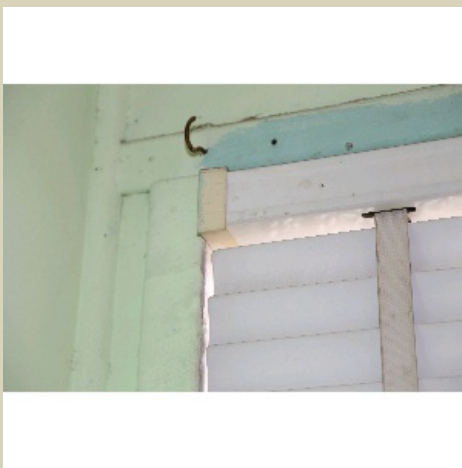
IMG_0131.jpg

Name	Asbestos window trim 2
Caption	Window architrave made from moulded asbestos cement
Location	Domestic home
Source	Asbestos Education Committee
Image Id	47

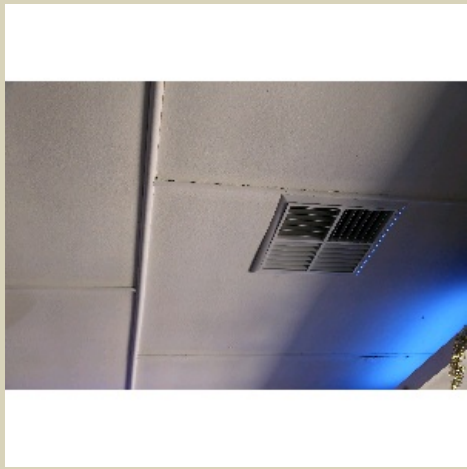
AC Ceiling.JPG

Name	Ceiling joining strip
Caption	Joining strips on AC sheeting ceiling
Location	Commercial
Source	Prensa
Image Id	335

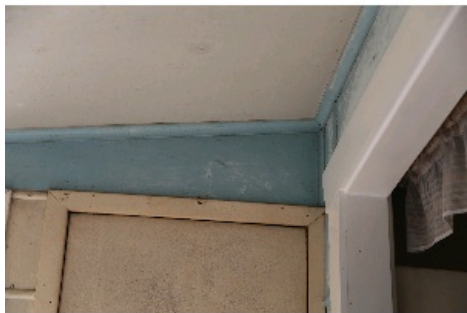
AAD WCS 031.JPG

Name	AC Cornice & Door Architrave
Caption	AC Cornice & Door Architrave, AC Wall and Ceiling
Location	Domestic home
Source	Asbestos Awareness
Image Id	336

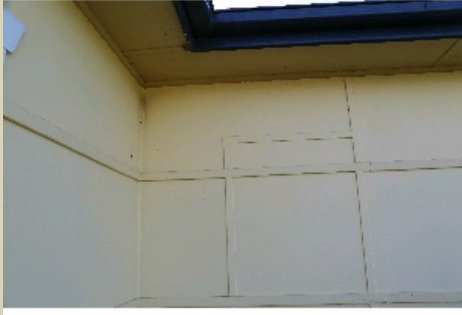
AAD WCS 013.JPG

Name	Exterior Joining Strips
Caption	Exterior Joining Strips
Location	Domestic home
Source	Asbestos Awareness
Image Id	337

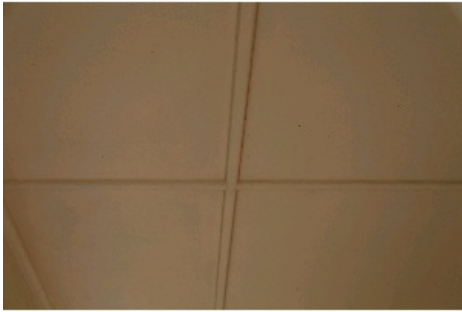
Internal Ceiling 2550 Courtesy Asbestos Awareness.JPG

Name	Ceiling joining strip
Caption	Ceiling joining strips
Location	Domestic home
Source	Asbestos Awareness
Image Id	338

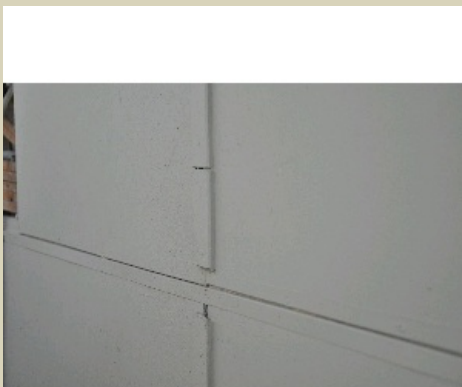
0075AsbestosProduct.JPG

Name	Exterior Joining Strips
Caption	Broken exterior / external moulded asbestos joining strips on AC wall
Location	Domestic home

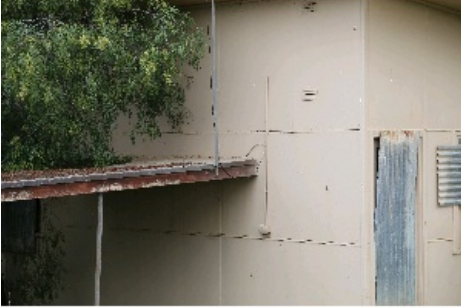
External Walls 2336 Courtesy Asbestos Awareness.JPG

Caption Exterior Joining Strips on AC cement wall

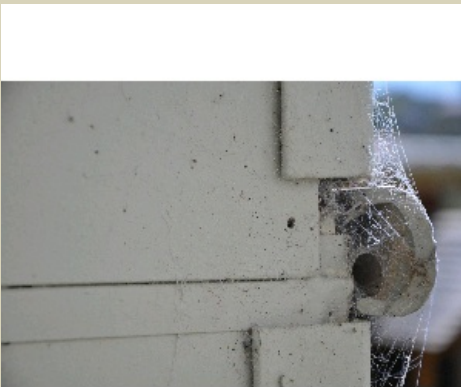
Exterior moulded asbestos joining strip 073.JPG

Caption Close up of exterior joining strip end and corner capping on AC cement wall

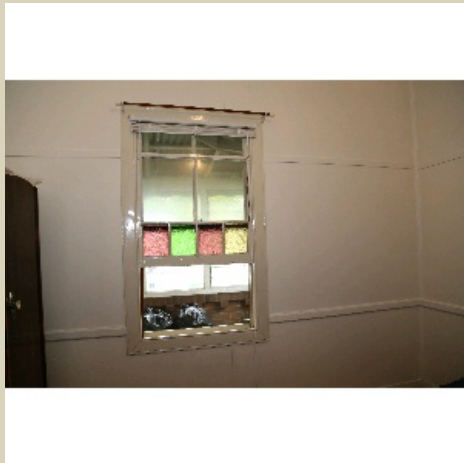
Asbestos Cement Walls_0296.JPG

Caption Asbestos cement wall with moulded asbestos joining strips.

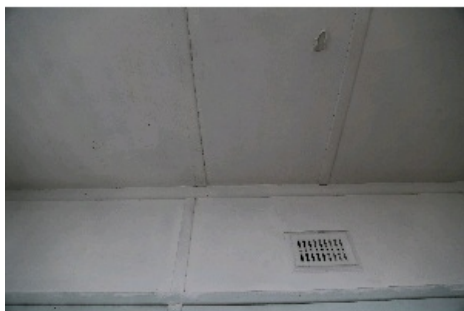
IMG_0138.jpg

Caption Asbestos cement ceiling and wall with moulded asbestos joining strips and cornice.

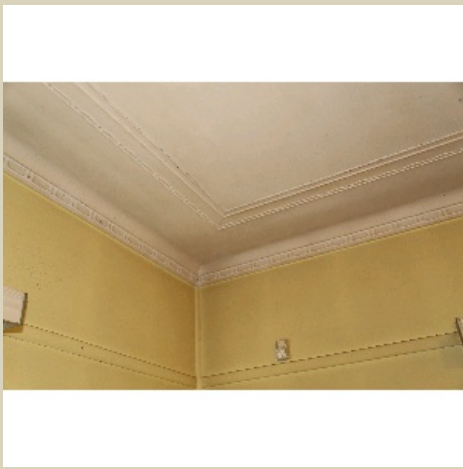
IMG_0163.jpg

Caption Asbestos cement wall with moulded asbestos joining strips.

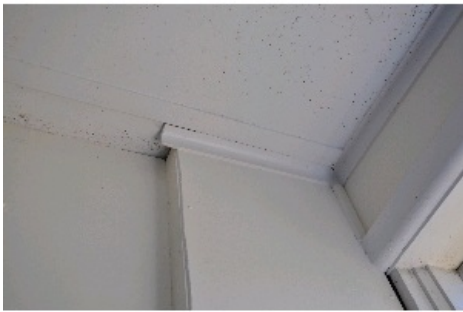
0068AsbestosProduct.JPG

Caption Moulded Asbestos Cornice on AC wall and ceiling
