Product: Eaves

Product Name	Eaves
Product type	Roofing, Guttering & Exterior
Sub-Product type	
Trading name(s)	Hardiflex
Other name(s)	
Product description	Eaves are the part of a roof which meets or overhangs the walls of a building. Until the mid-late 1980s they were constructed of bonded asbestos sheeting. Signs of deterioration include discolouration, cracking or splitting.
Build element	Construction
Product identification	
Known uses	Eaves
Asbestos fibre type	Amosite (brown asbestos) Chrysotile (white asbestos) Crocidolite (blue asbestos)
Friable or Non-Friable	Non-Friable
Known Supplier(s)	James Hardie
Known place of manufacture	
Date / period of manufacture	
Building construction period	1931-1940, 1941-1950, 1951-1960, 1961-1970, 1970-1980, 1981-1990
Location	<p>Domestic home</p> <ul style="list-style-type: none"> • Bathroom • Bedroom • Dining room • Dog kennels • Exterior • Roofing & guttering <p>Agricultural</p> <p>Commercial</p> <ul style="list-style-type: none"> • Building structure • Roofing & guttering <p>Industrial</p> <ul style="list-style-type: none"> • Building structure • Roofing & guttering

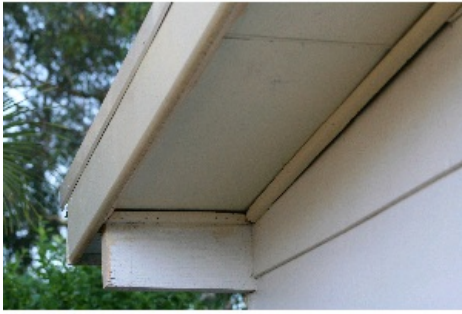
0024AsbestosProduct.JPG

Name Asbestos cement eaves - maintained

Caption The asbestos cement eaves are well maintained.

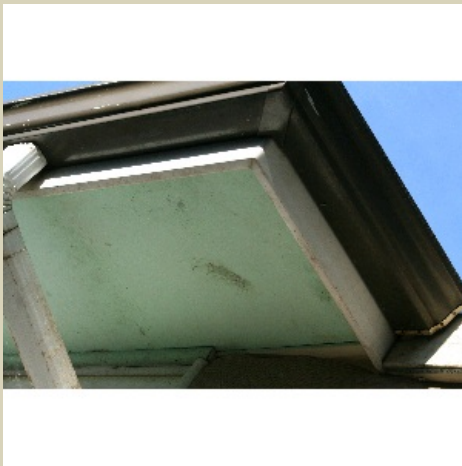
0026AsbestosProduct.JPG

Name Asbestos cement eaves - maintained

Caption The asbestos cement eaves are well maintained.

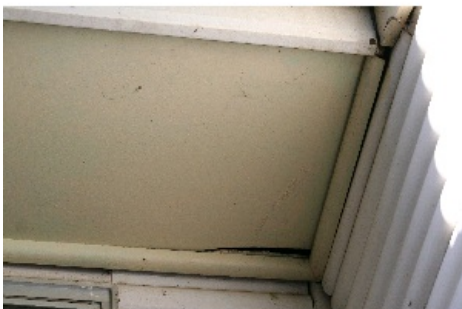
0034AsbestosProduct.JPG

Name Asbestos eave and corrugated cladding

Flat asbestos cement eave and on house with corrugated asbestos cement cladding

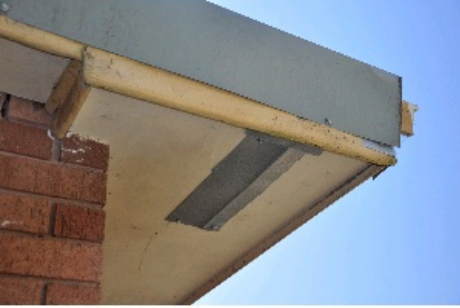
0065AsbestosProduct.JPG

Name Asbestos cement eaves - damaged**Caption** Asbestos cement eaves - HAZARD. The broken fibro has been repaired by drilling a metal plate over the broken piece. This is extremely dangerous as drilling releases fibres directly into the face of the renovator.**Location** Domestic home**Source** Asbestos Education Committee**Image Id** 157

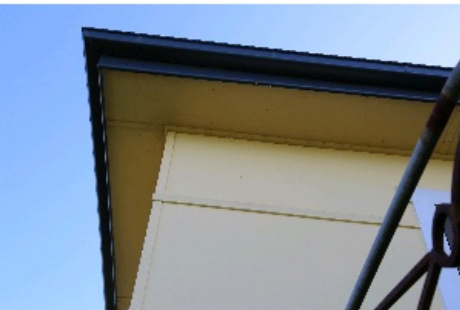
AAD WCS 026.JPG

Name Eaves and Exterior Cladding**Caption** Asbestos Cement eaves and exterior cladding**Location** Domestic home**Source** Asbestos Education Committee**Image Id** 158

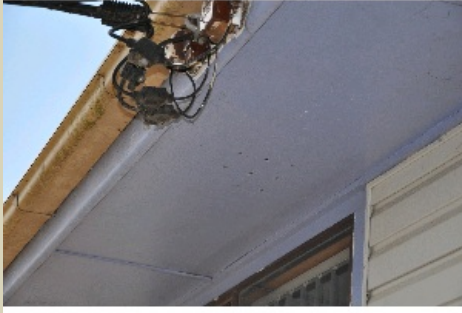
AsbestosHouses 115.JPG

Name Asbestos cement eaves - maintained

Caption Hardiflex soffit sheeting with drilled diamond pattern. The asbestos cement is newly painted and well maintained.

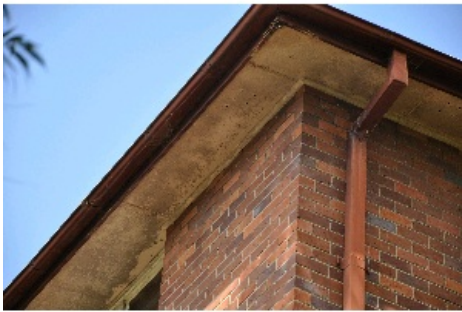
AsbestosHouses 298.JPG

Name Fibro Eaves - Brick apartments

Caption 1970s brick apartment building with asbestos cement eaves in need of repair as paint has peeled exposing the asbestos cement

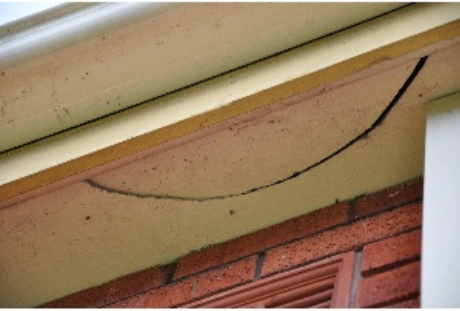
DSC_0083.JPG

Name Asbestos cement eaves - damaged

Caption Brick home with broken fibro eaves

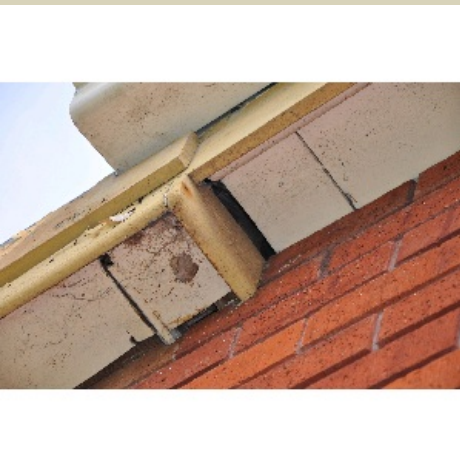
DSC_0084.JPG

Name Asbestos cement eaves - damaged

Caption Brick home with damaged fibro eaves

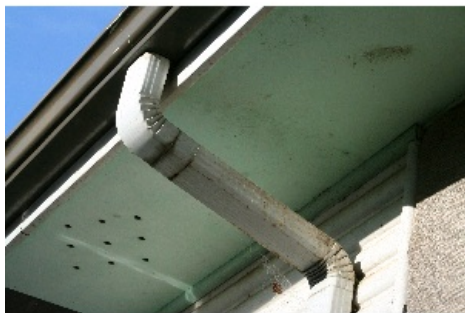
guttering and eaves_5971.jpg

Name	Eaves with drilled diamond pattern
Caption	Hardiflex soffit sheeting with drilled diamond pattern
Location	Domestic home
Source	Asbestos Awareness
Image Id	164

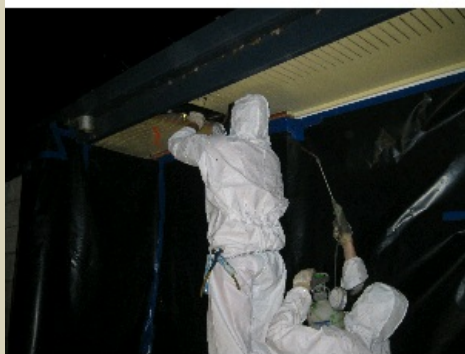
Soffit - eave removal.jpg

Name	Soffit eaves
Caption	Eaves made from slotted hardi flex soffit sheeting. Asbestos sheeting machined with slits to allow air flow through to the ceiling cavity.
Location	Commercial
Source	Archive
Image Id	165
