Product: Eaves

Product Name	Eaves
Product type	Roofing, Guttering & Exterior
Sub-Product type	
Trading name(s)	Hardiflex
Other name(s)	
Product description	Eaves are the part of a roof which meets or overhangs the walls of a building. Until the mid-late 1980s they were constructed of bonded asbestos sheeting. Signs of deterioration include discolouration, cracking or splitting.
Build element	Construction
Product identification	
Known uses	Eaves
Asbestos fibre type	Amosite (brown asbestos) Chrysotile (white asbestos) Crocidolite (blue asbestos)
Friable or Non-Friable	Non-Friable
Known Supplier(s)	James Hardie
Known place of manufacture	
Date / period of manufacture	
Building construction period	1931-1940, 1941-1950, 1951-1960, 1961-1970, 1970-1980, 1981-1990
Location	<p>Domestic home</p> <ul style="list-style-type: none"> • Bathroom • Bedroom • Dining room • Dog kennels • Exterior • Roofing & guttering <p>Agricultural</p> <p>Commercial</p> <ul style="list-style-type: none"> • Building structure • Roofing & guttering <p>Industrial</p> <ul style="list-style-type: none"> • Building structure • Roofing & guttering

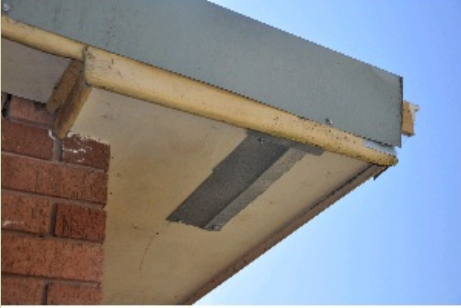
0065AsbestosProduct.JPG

Name Asbestos cement eaves - damaged**Caption** Asbestos cement eaves - HAZARD. The broken fibro has been repaired by drilling a metal plate over the broken piece. This is extremely dangerous as drilling releases fibres directly into the face of the renovator.**Location** Domestic home**Source** Asbestos Education Committee**Image Id** 157

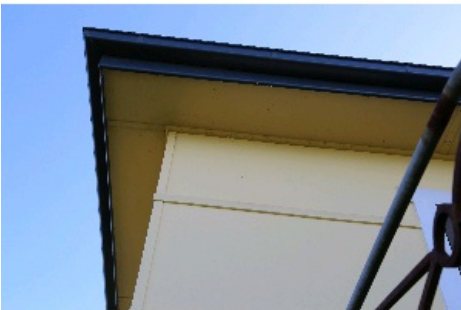
AAD WCS 026.JPG

Name Eaves and Exterior Cladding**Caption** Asbestos Cement eaves and exterior cladding**Location** Domestic home**Source** Asbestos Education Committee**Image Id** 158

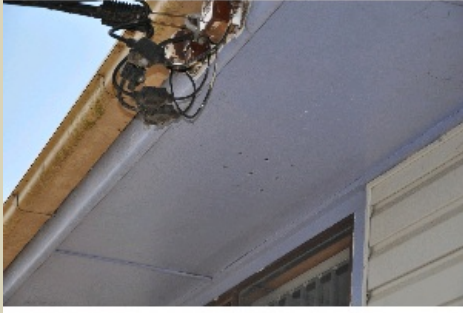
AsbestosHouses 115.JPG

Name Asbestos cement eaves - maintained

Caption Hardiflex soffit sheeting with drilled diamond pattern. The asbestos cement is newly painted and well maintained.

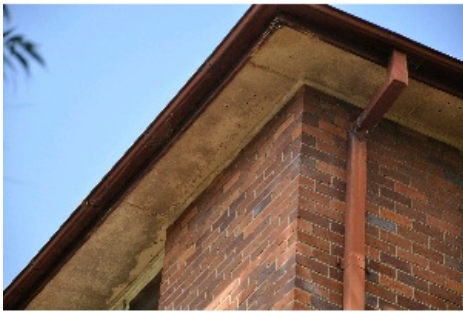
AsbestosHouses 298.JPG

Name Fibro Eaves - Brick apartments

Caption 1970s brick apartment building with asbestos cement eaves in need of repair as paint has peeled exposing the asbestos cement

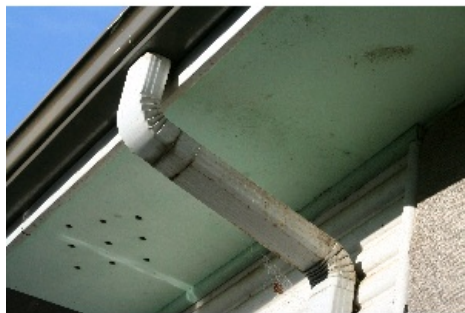
guttering and eaves_5971.jpg

Name	Eaves with drilled diamond pattern
Caption	Hardiflex soffit sheeting with drilled diamond pattern
Location	Domestic home
Source	Asbestos Awareness
Image Id	164

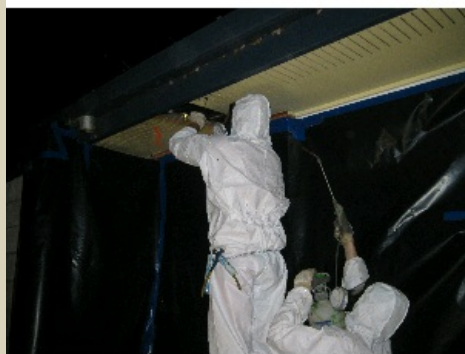
Soffit - eave removal.jpg

Name	Soffit eaves
Caption	Eaves made from slotted hardi flex soffit sheeting. Asbestos sheeting machined with slits to allow air flow through to the ceiling cavity.
Location	Commercial
Source	Archive
Image Id	165
