Product: Imitation brick cladding

Product type Cement - sheets, moulded product

Product description The imitation brick may contain asbestos, however the sheeting located behind was commonly asbestos containing sheeting. The imitation brick was commonly nailed onto the asbestos sheeting.

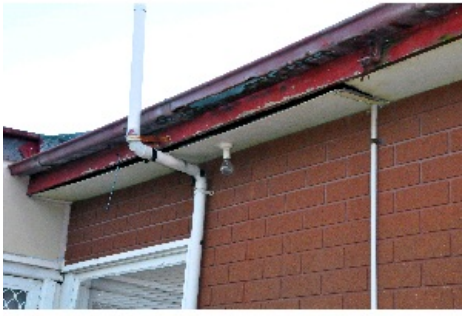
Fake Brick Cladding_0696c.jpg

Name Imitation brick cladding - exterior

Caption Exterior imitation / fake brick cladding and asbestos cement eaves

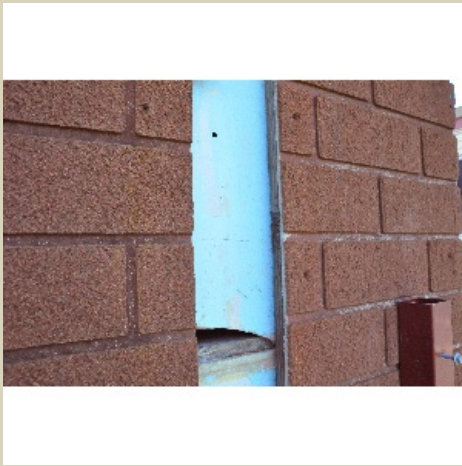
Fake Brick Cladding_0700.jpg

Name Imitation brick cladding - exterior

Caption Close up of exterior imitation / fake brick cladding. The asbestos cement sheeting is visible.

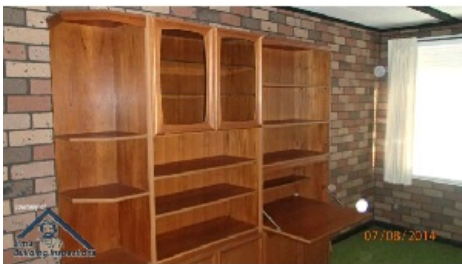
JBIFake Brick Cladding - Confirmed (2).jpg

Name Imitation brick sheeting - internal wall

Caption Imitation brick sheeting within a domestic living room.

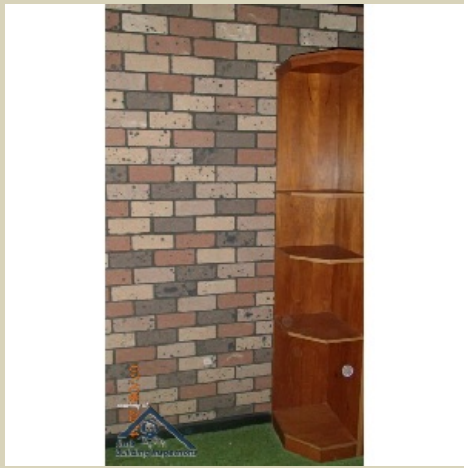
JBI_Fake Brick Cladding - Confirmed.jpg

Name Imitation brick sheeting - internal wall

Caption Imitation brick sheeting within a domestic living room.

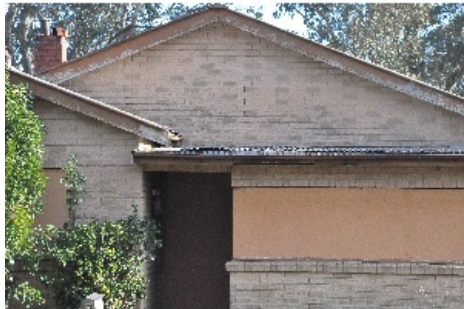
DSC_0553.JPG

Name Imitation brick cladding - exterior

Caption Exterior imitation / fake brick cladding. Asbestos cement sheeting is behind the fake bricks.

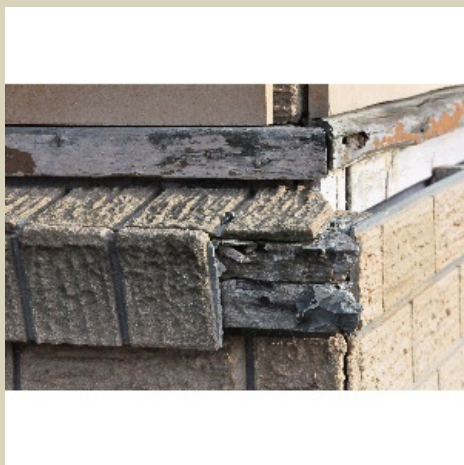
DSC_0554.JPG

Name Imitation brick cladding - exterior close up

Caption Close up of imitation brick cladding on the broken exterior window ledge which shows the asbestos cement sheeting behind the fake brick.

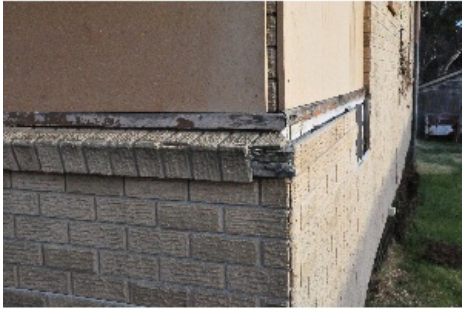
DSC_0556.JPG

Name Imitation brick cladding - exterior

Caption Exterior imitation / fake brick cladding. Asbestos cement sheeting is behind the fake bricks.
