Product: Carpet Underlay & Adhesive

Product Name	Carpet Underlay & Adhesive
Product type	Flooring
Sub-Product type	
Trading name(s)	
Other name(s)	
Product description	<p>Asbestos was carried in hessian bags from Wittenoon in Western Australia which was then subsequently used in some carpet underlay. Also asbestos was used in the adhesive to glue down the carpet underlay which is usually a black bitumous material.</p> <p>Asbestos was used in the adhesive to glue down the carpet underlay which is usually a black bitumous material.</p>
Build element	
Product identification	<p>The exact characteristics of the suspect underlay are not fully known. However, it is likely to be brown in colour and look like a fibrous mat. It is also likely to be compacted as it has been under the carpet and walked on. In most cases, the underlay was either glued on to a concrete floor or stapled on to a timber floor. Other types of underlay (eg. rubber, foam) are not known to contain asbestos.</p> <p>Asbestos was used in the adhesive to glue down the carpet underlay which is usually a black bitumous material.</p>

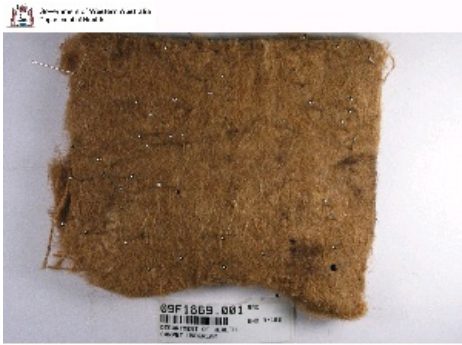
carpet underlay Photo Courtesy of WA Health - logo.jpg

Name	Carpet Underlay
Caption	Sample of carpet underlay
Location	Domestic home
Source	WA Health
Image Id	42

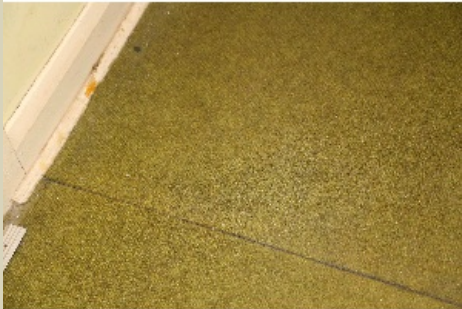
IMG_0160.jpg

Name	Carpet 2
Caption	Carpet which has asbestos underlay beneath it.
Location	Domestic home
Source	Asbestos Education Committee
Image Id	51

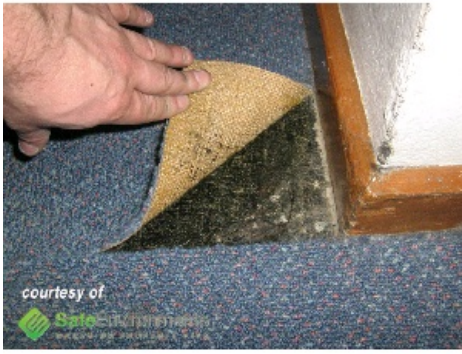
img-2358.jpg

Name Carpet Underlay - adhesive

Caption Asbestos was used in the adhesive to glue down the carpet underlay which is usually a black bituminous material.

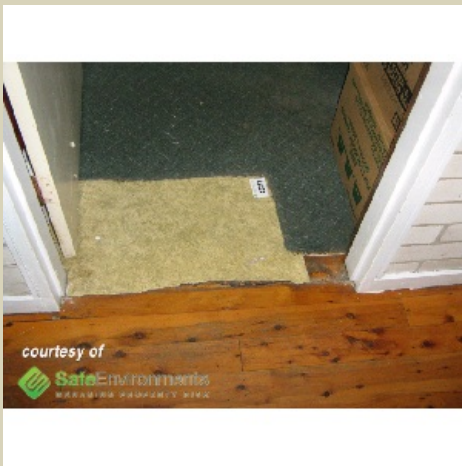
img-3498.jpg

Name Carpet Underlay 2

Caption Asbestos Carpet Underlay - light coloured hessian seen on left.

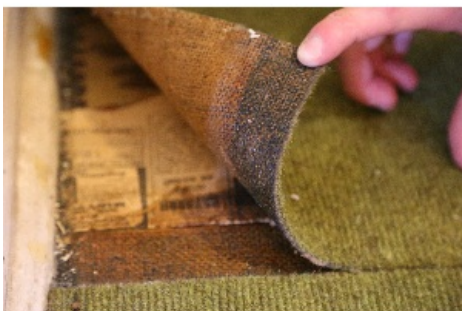
IMG_0518.JPG

Name Carpet Underlay - Glue

Caption Asbestos was used in the adhesive to glue down the carpet underlay which is usually a black bituminous

material. This photo is of carpet being directly glued to the ground.
